District of Lantzville

REPORT TO CAO

SUBJECT: District of Lantzville Sanitary Sewer Collection System Phase 2
Construction Update - Storm Drainage Installation – Bayview/Huddleston
Road & Lancewood Avenue

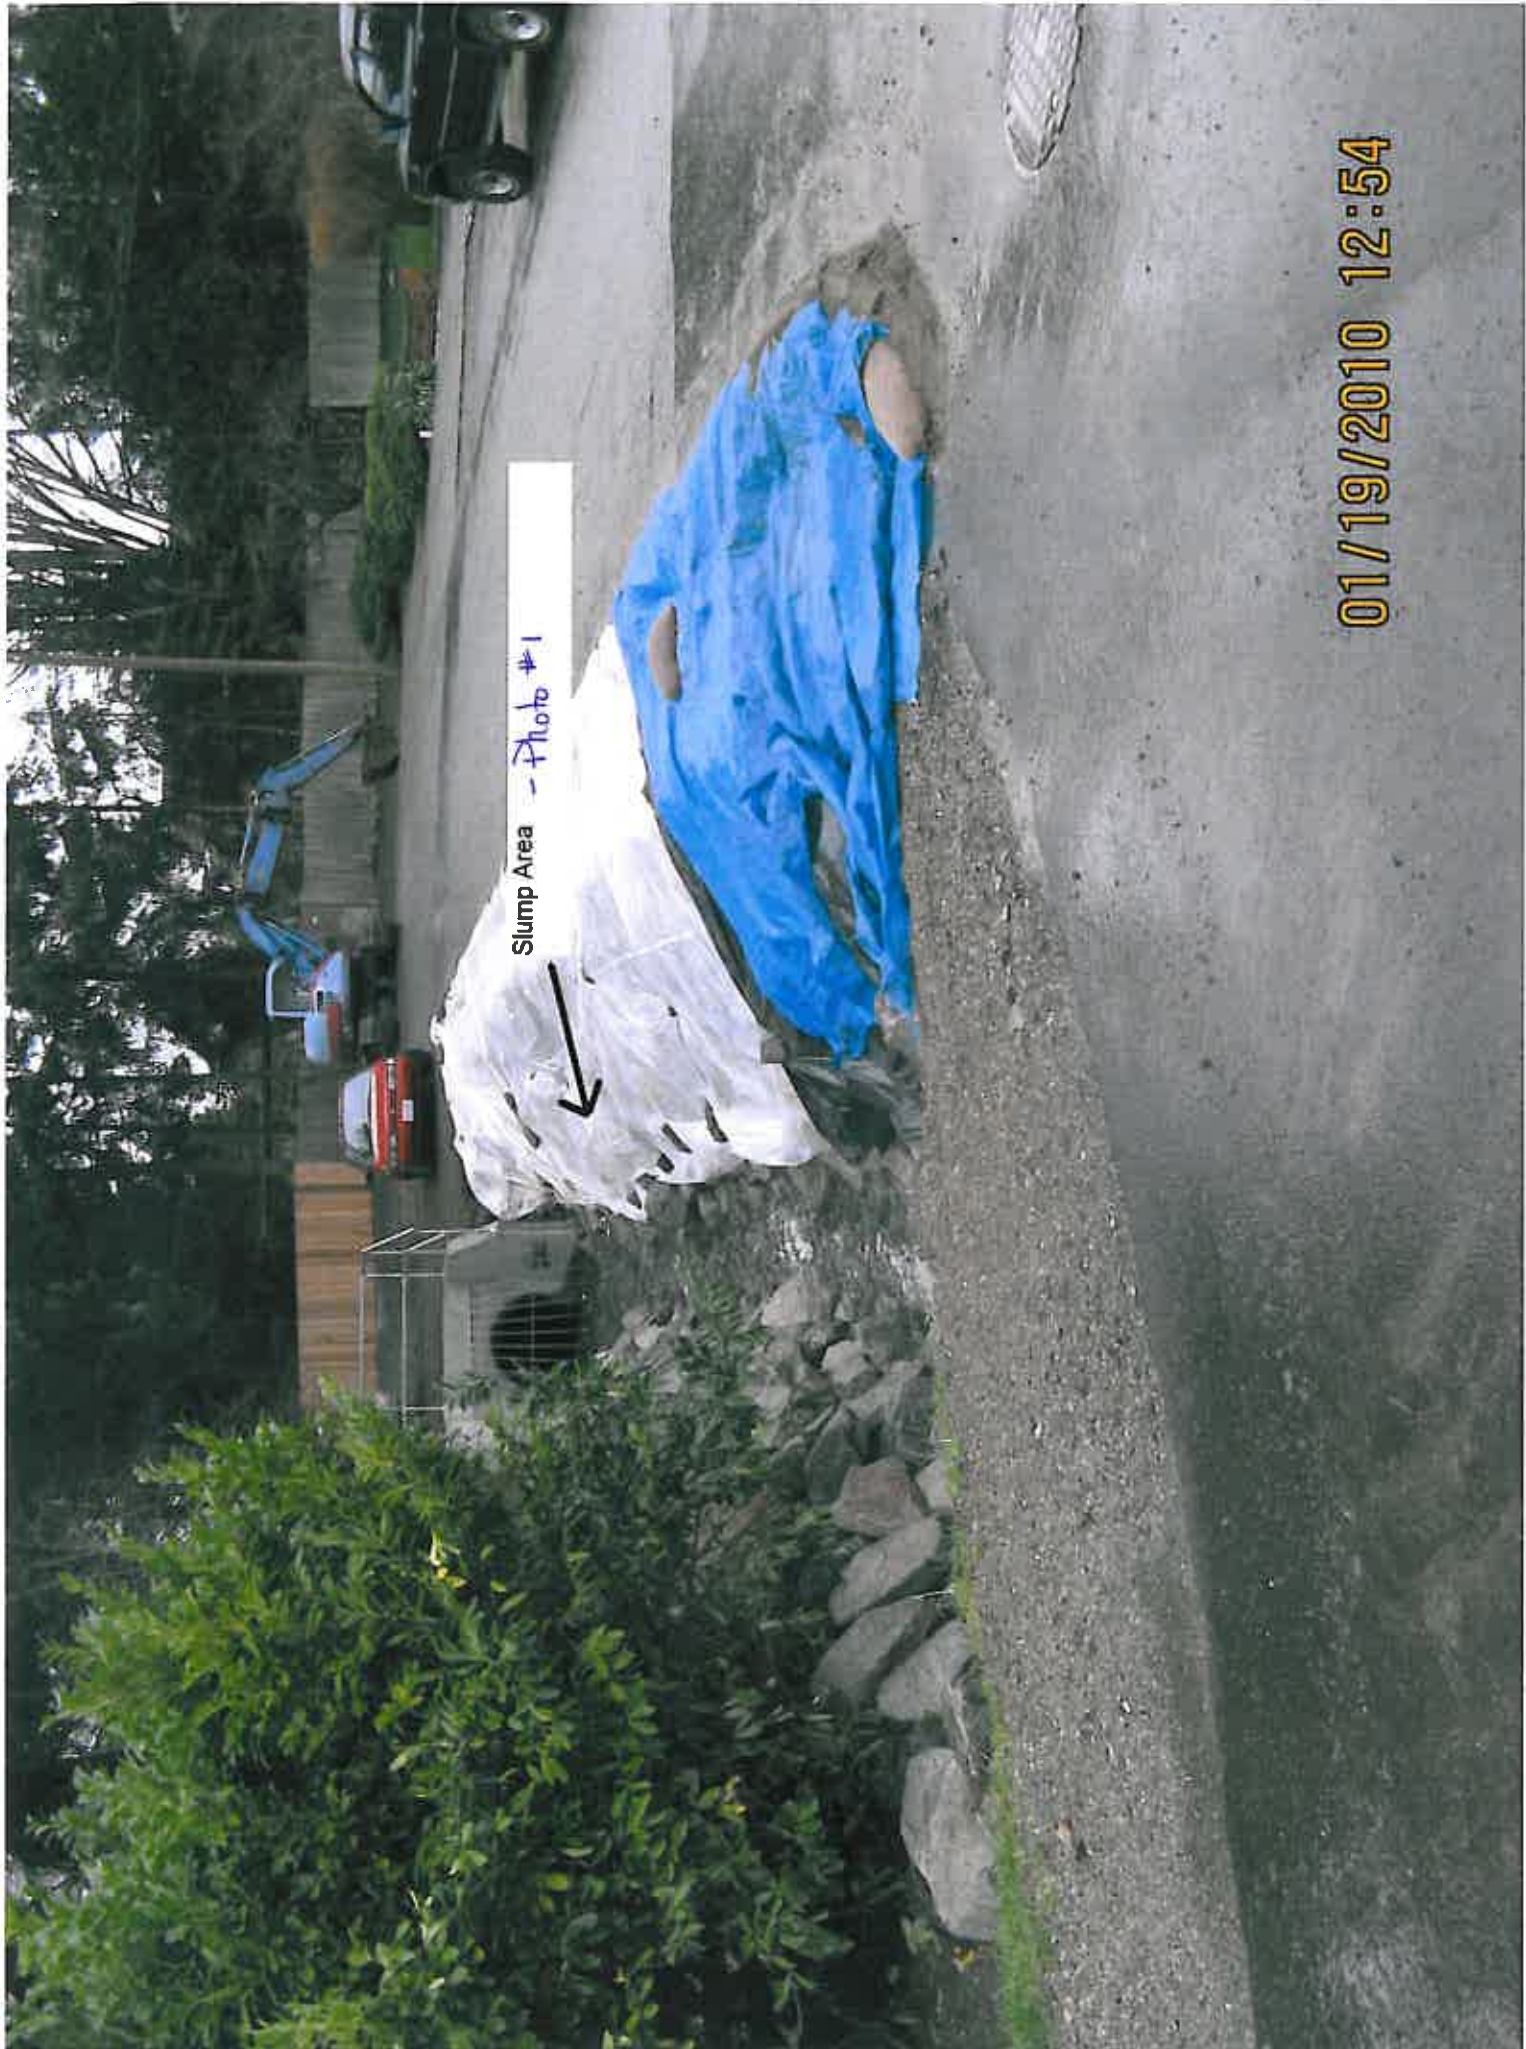
The Lancewood Ave. section of the storm drainage was initially completed in early December of 2009. Following construction completion, it was found that with the trench for the sanitary sewer collection line being so close to the storm drainage ditch the sanitary sewer line trench became inundated with water and had pushed the wall of the trench into the storm drainage ditch (see photo 1 attached).

The initial location/construction of the sewer line trench became inundated with water which resulted in causing pressure in the trench; this pressure caused the weakest point in the trench wall to fail. The failure happened at the bottom end of Lancewood Ave. where the storm drainage ditch and the sewer line trench wall were in close proximity to each other (approx. 1.5m) and reflected the original engineered design.

Slump Area - Photo #1

Upon review the only solution was to fill the recently constructed drainage ditch in with pipe and move the head wall further south on Lancewood Avenue. This solution gave staff and the engineers confidence that the sewer trench was now secure.

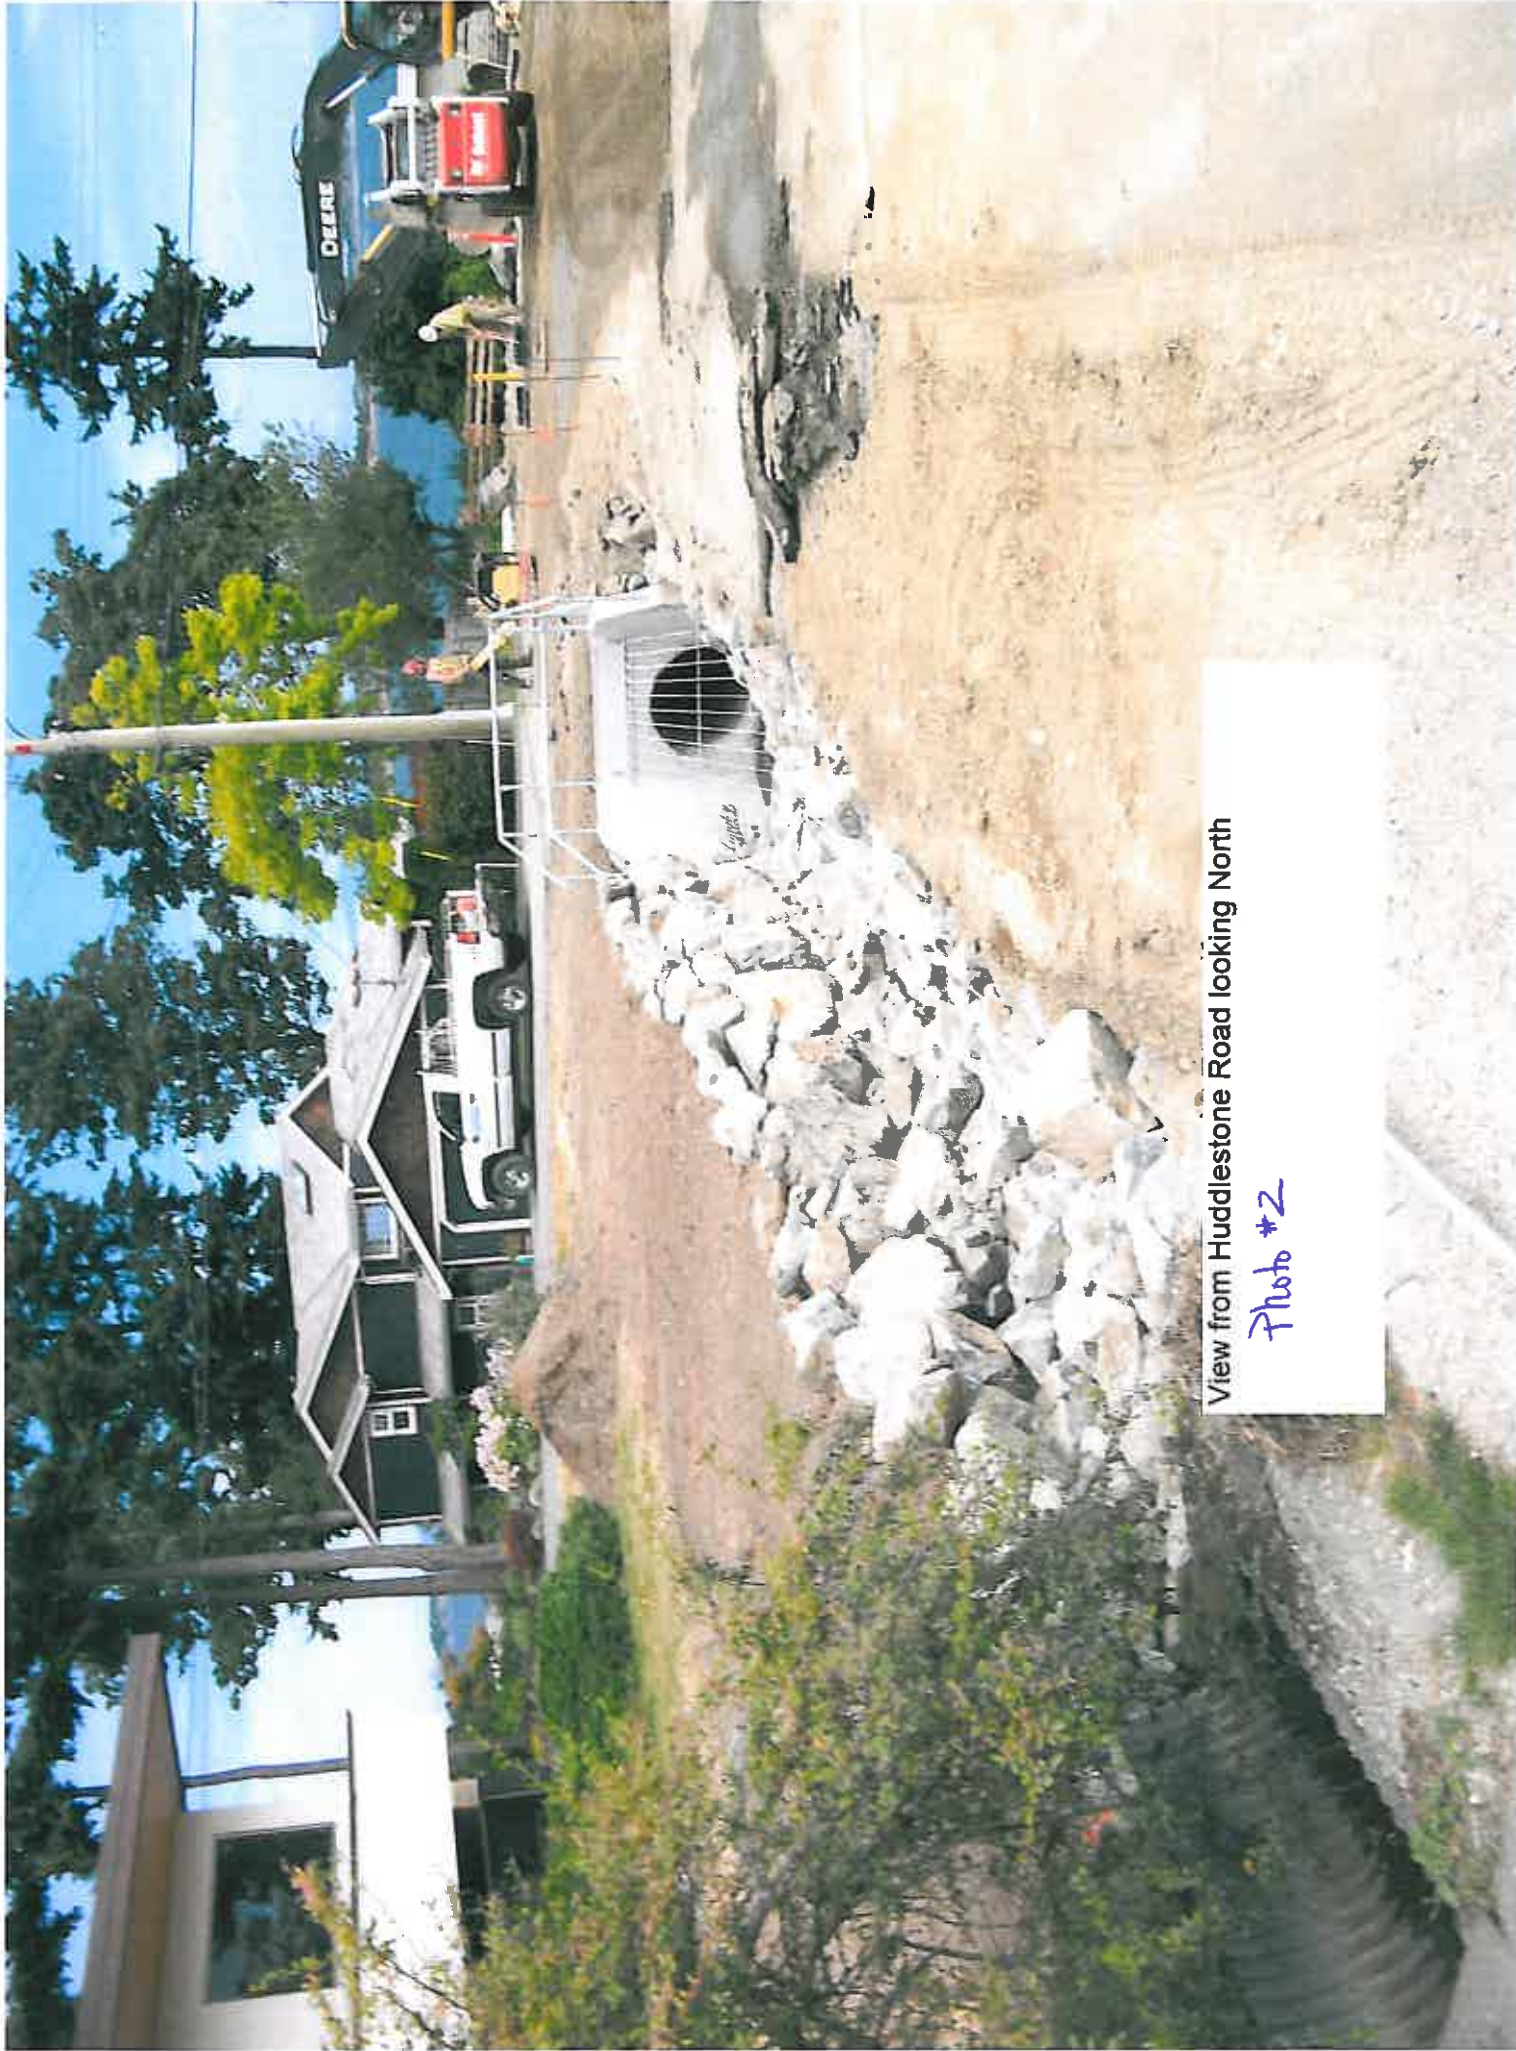
Photo #2

View from Huddlestone Road looking North

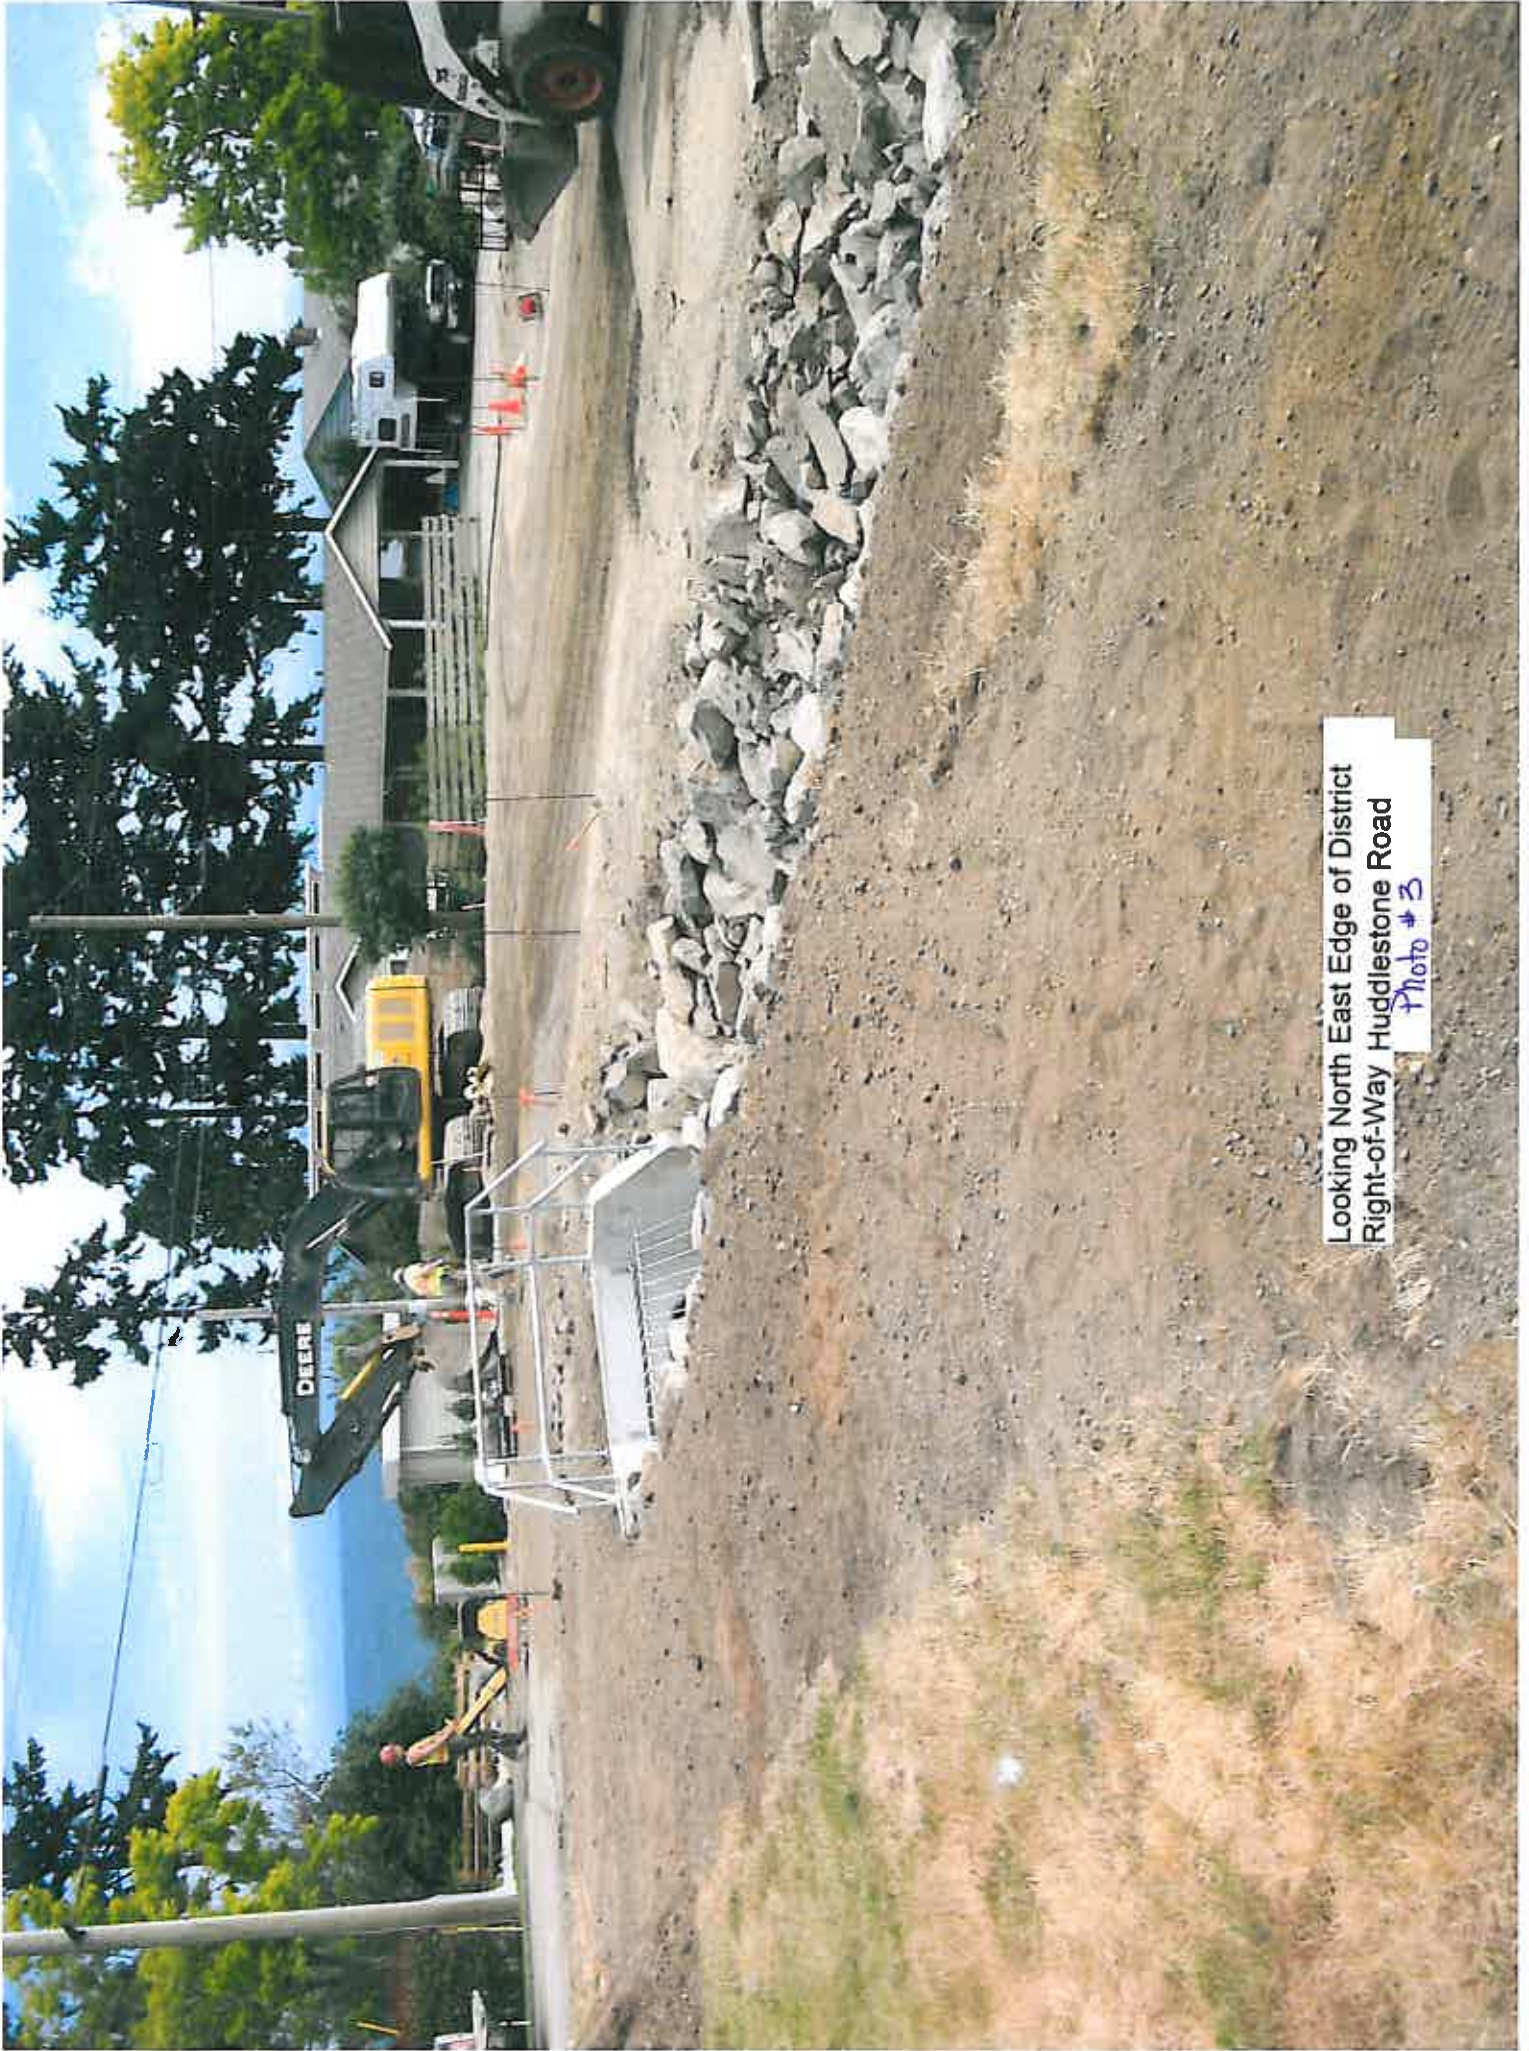
Looking North East Edge of District
Right-of-Way Huddleston Road
Photo # 3

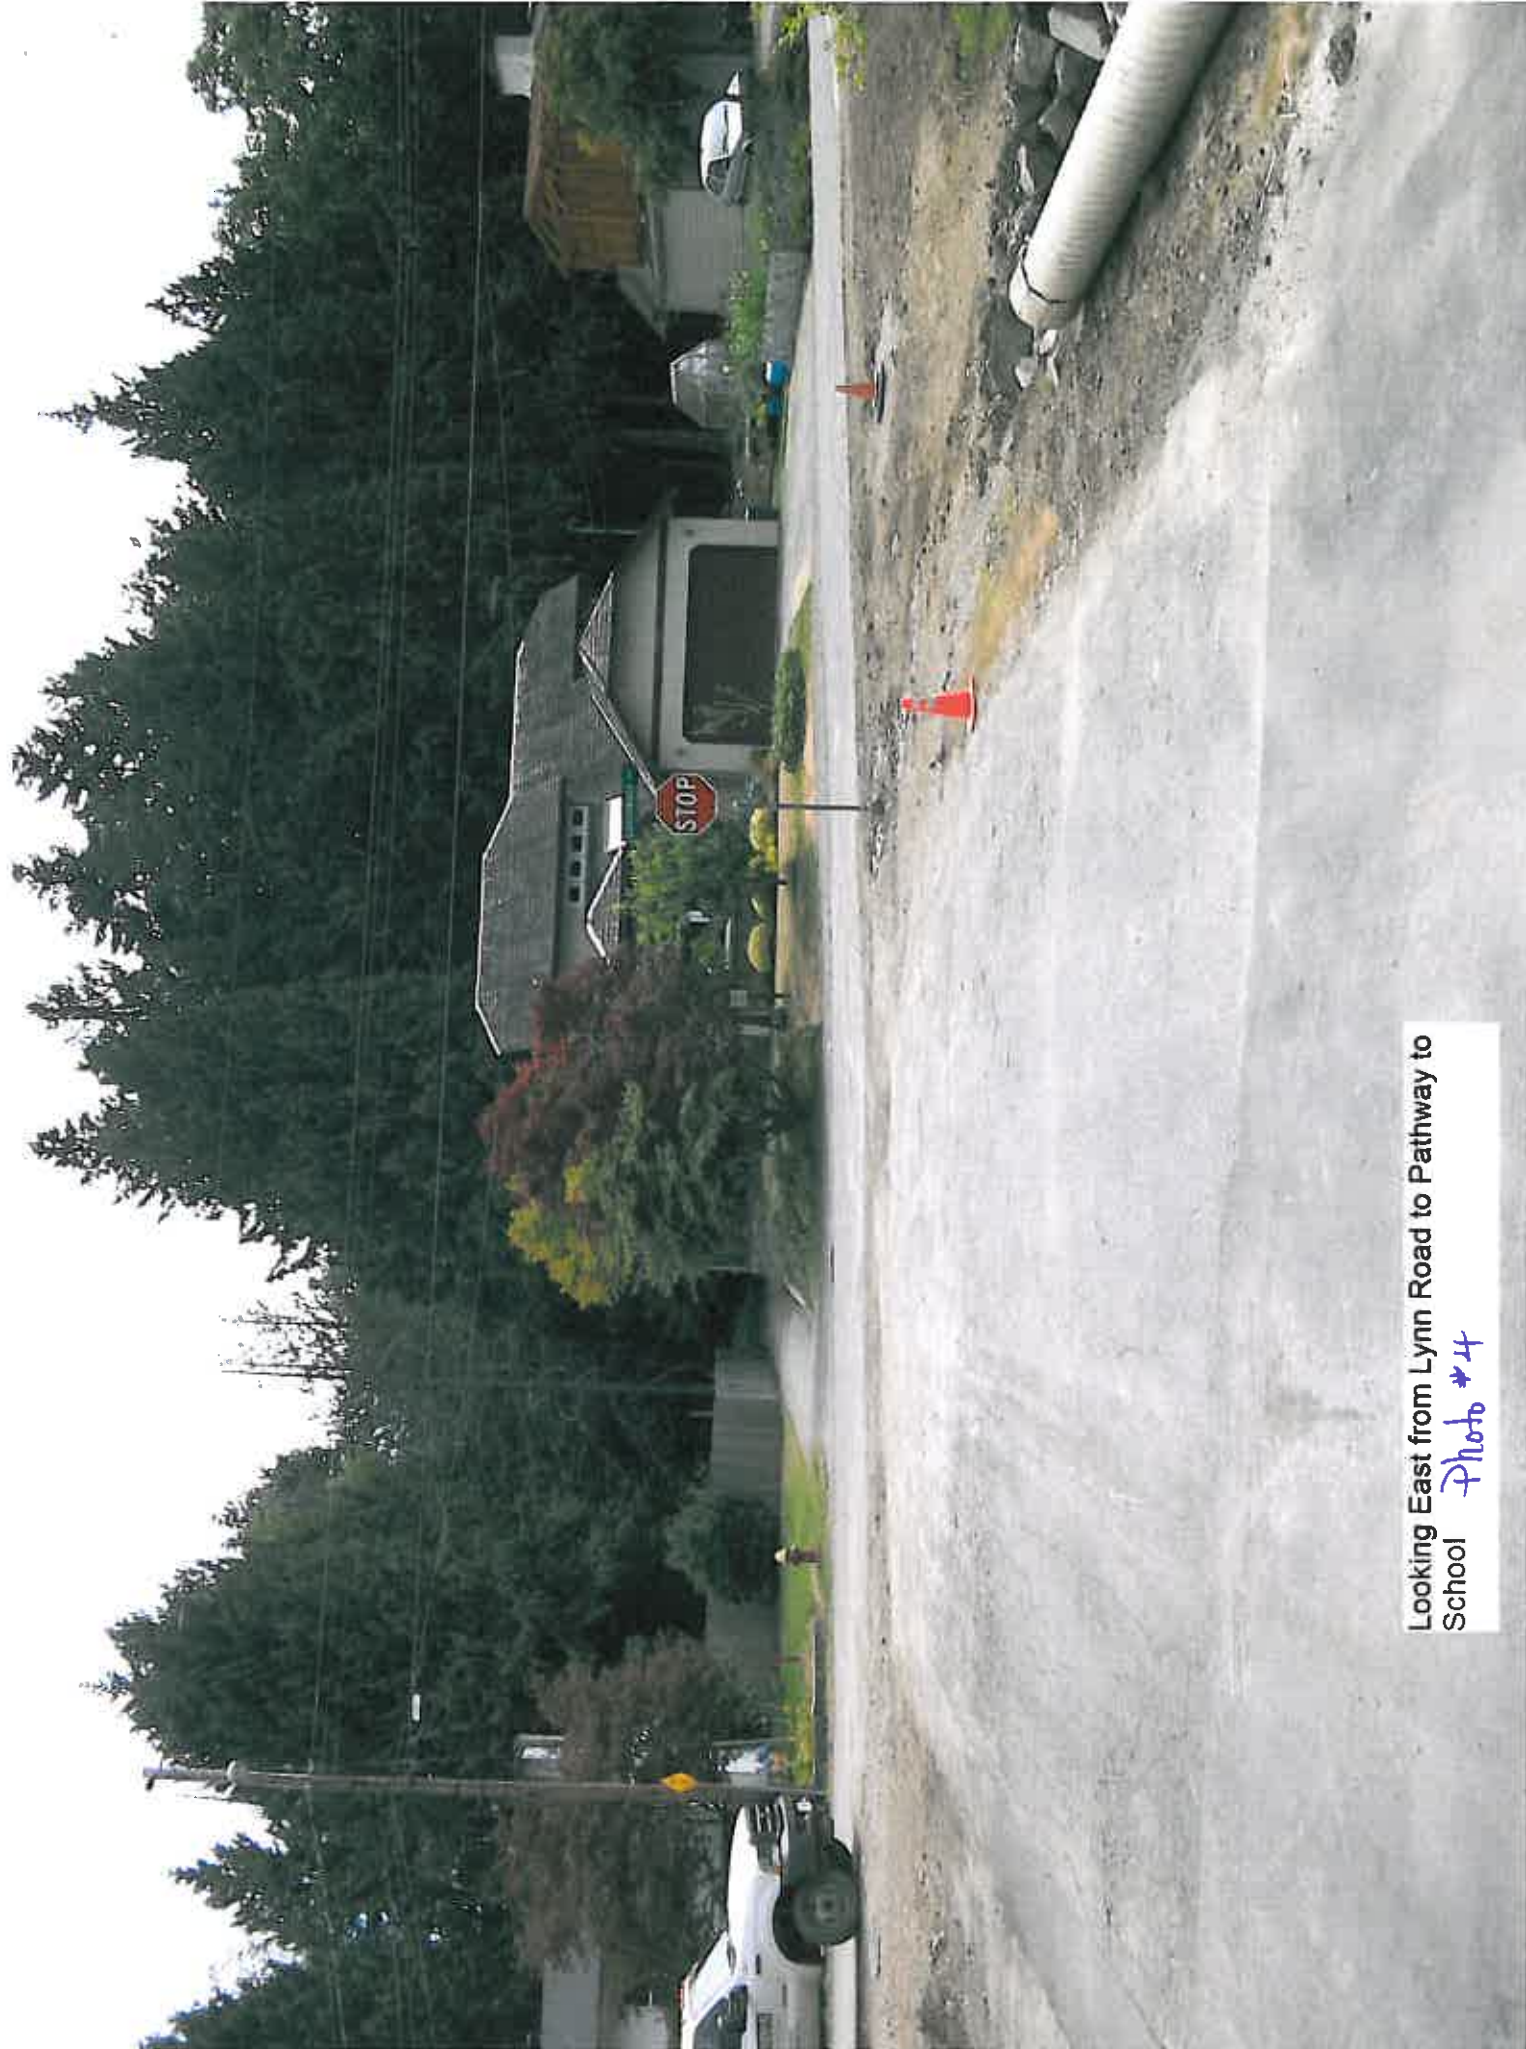
Looking East from Lynn Road to Pathway to School Photo #4

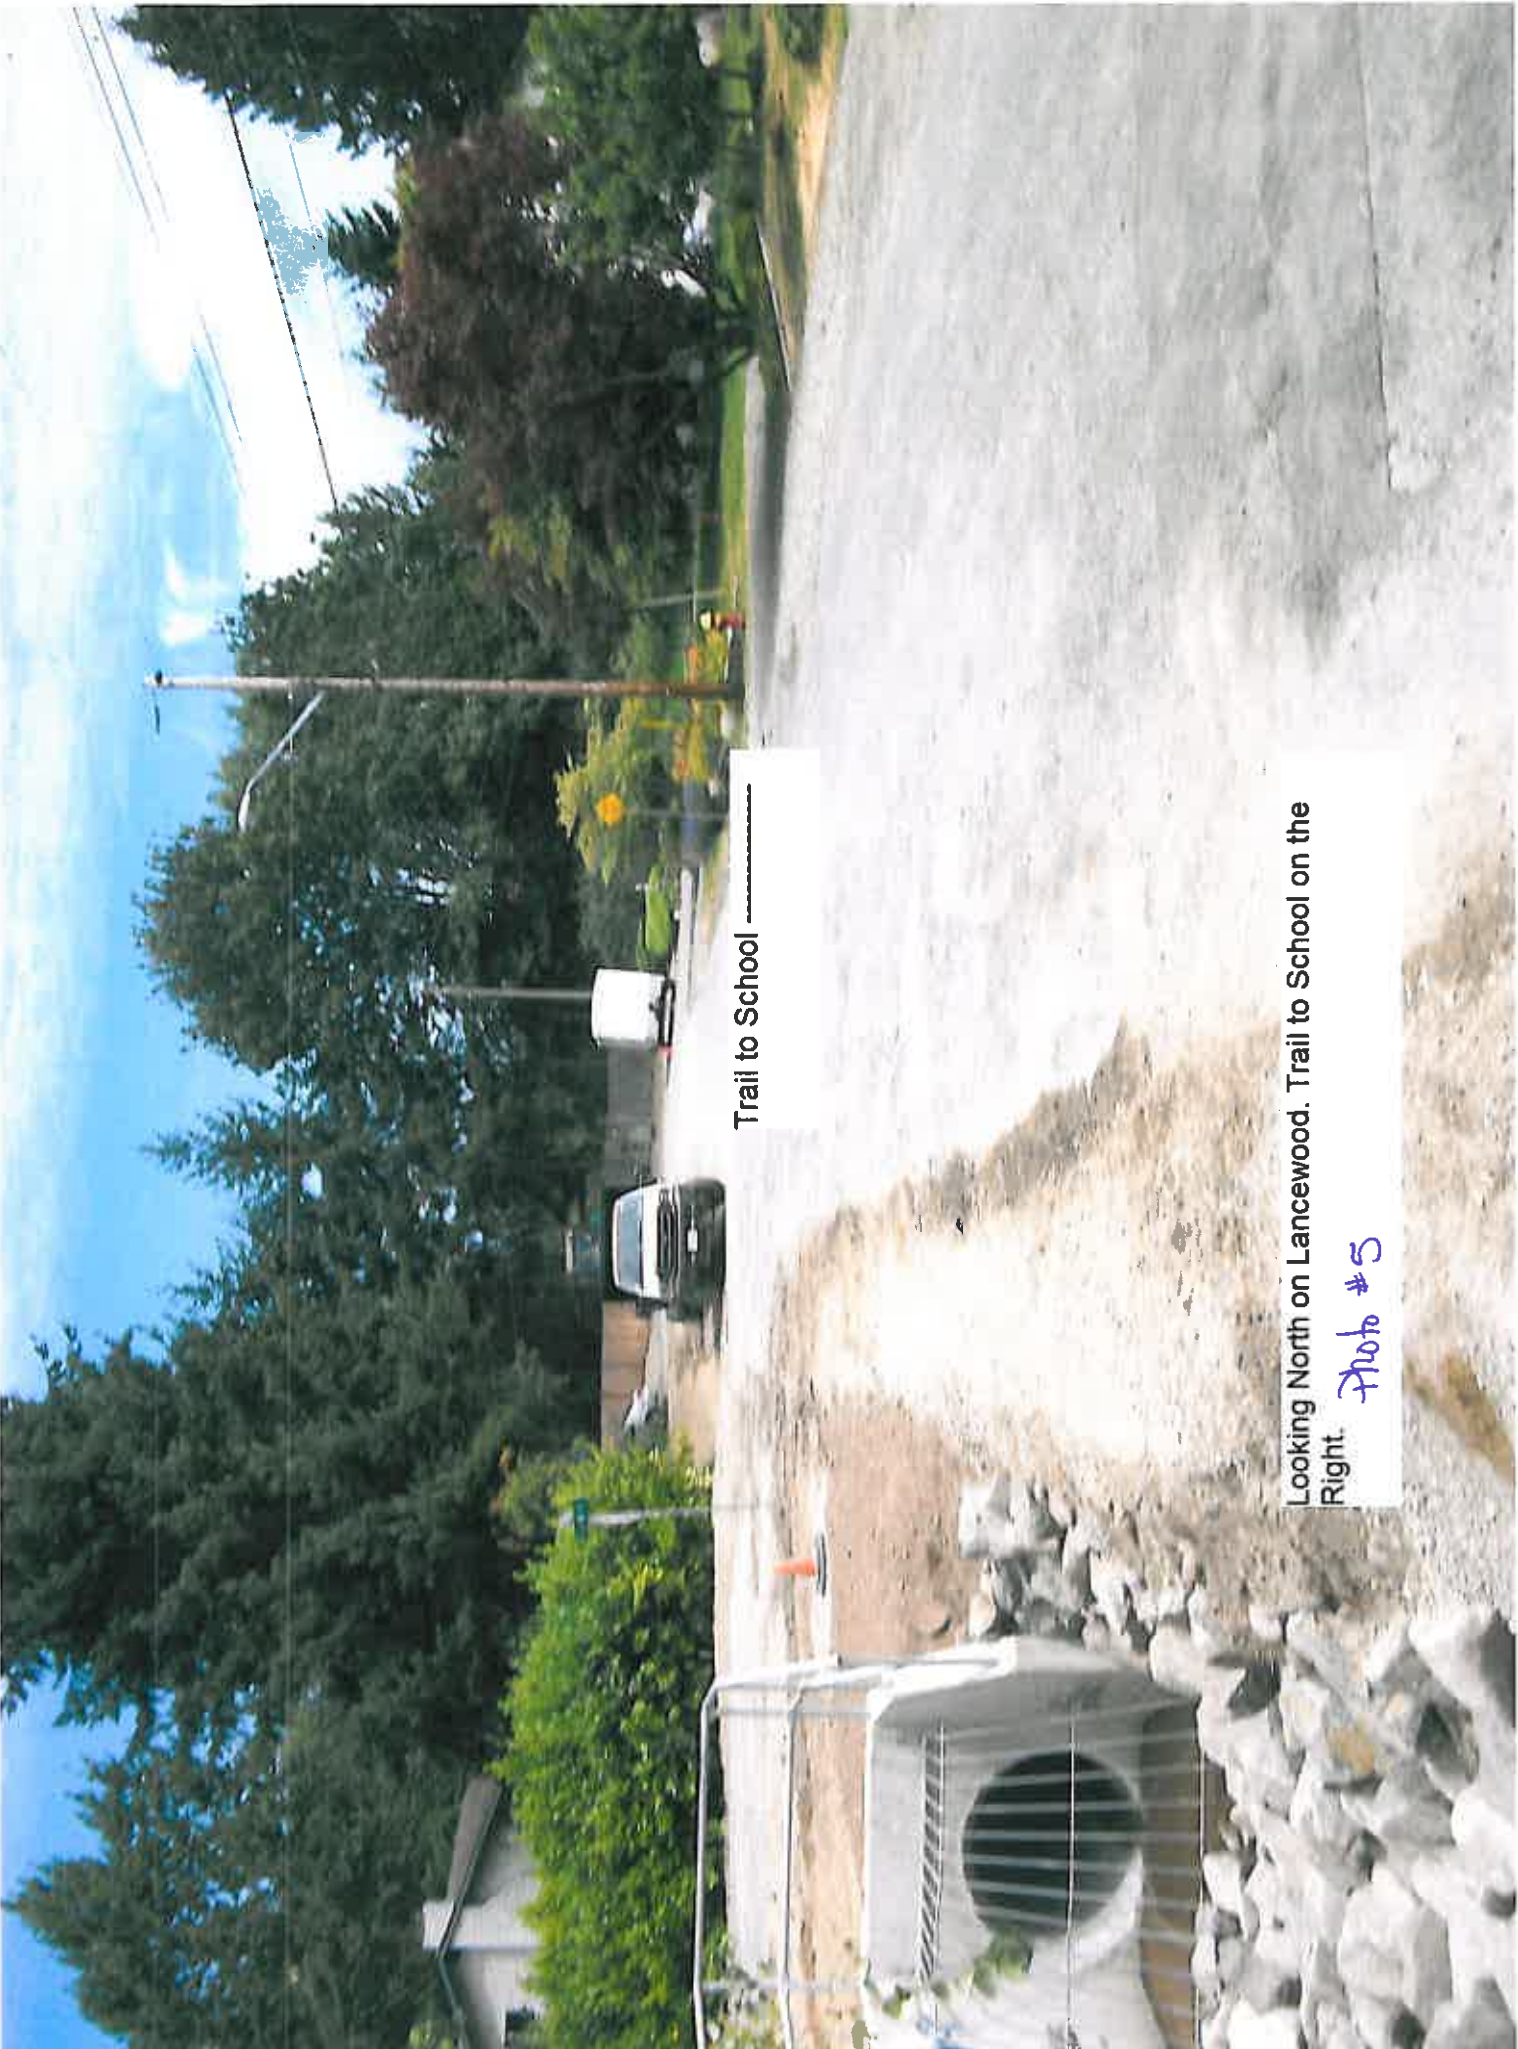
Photo #5

Looking North on Lancewood. Trail to School on the Right.

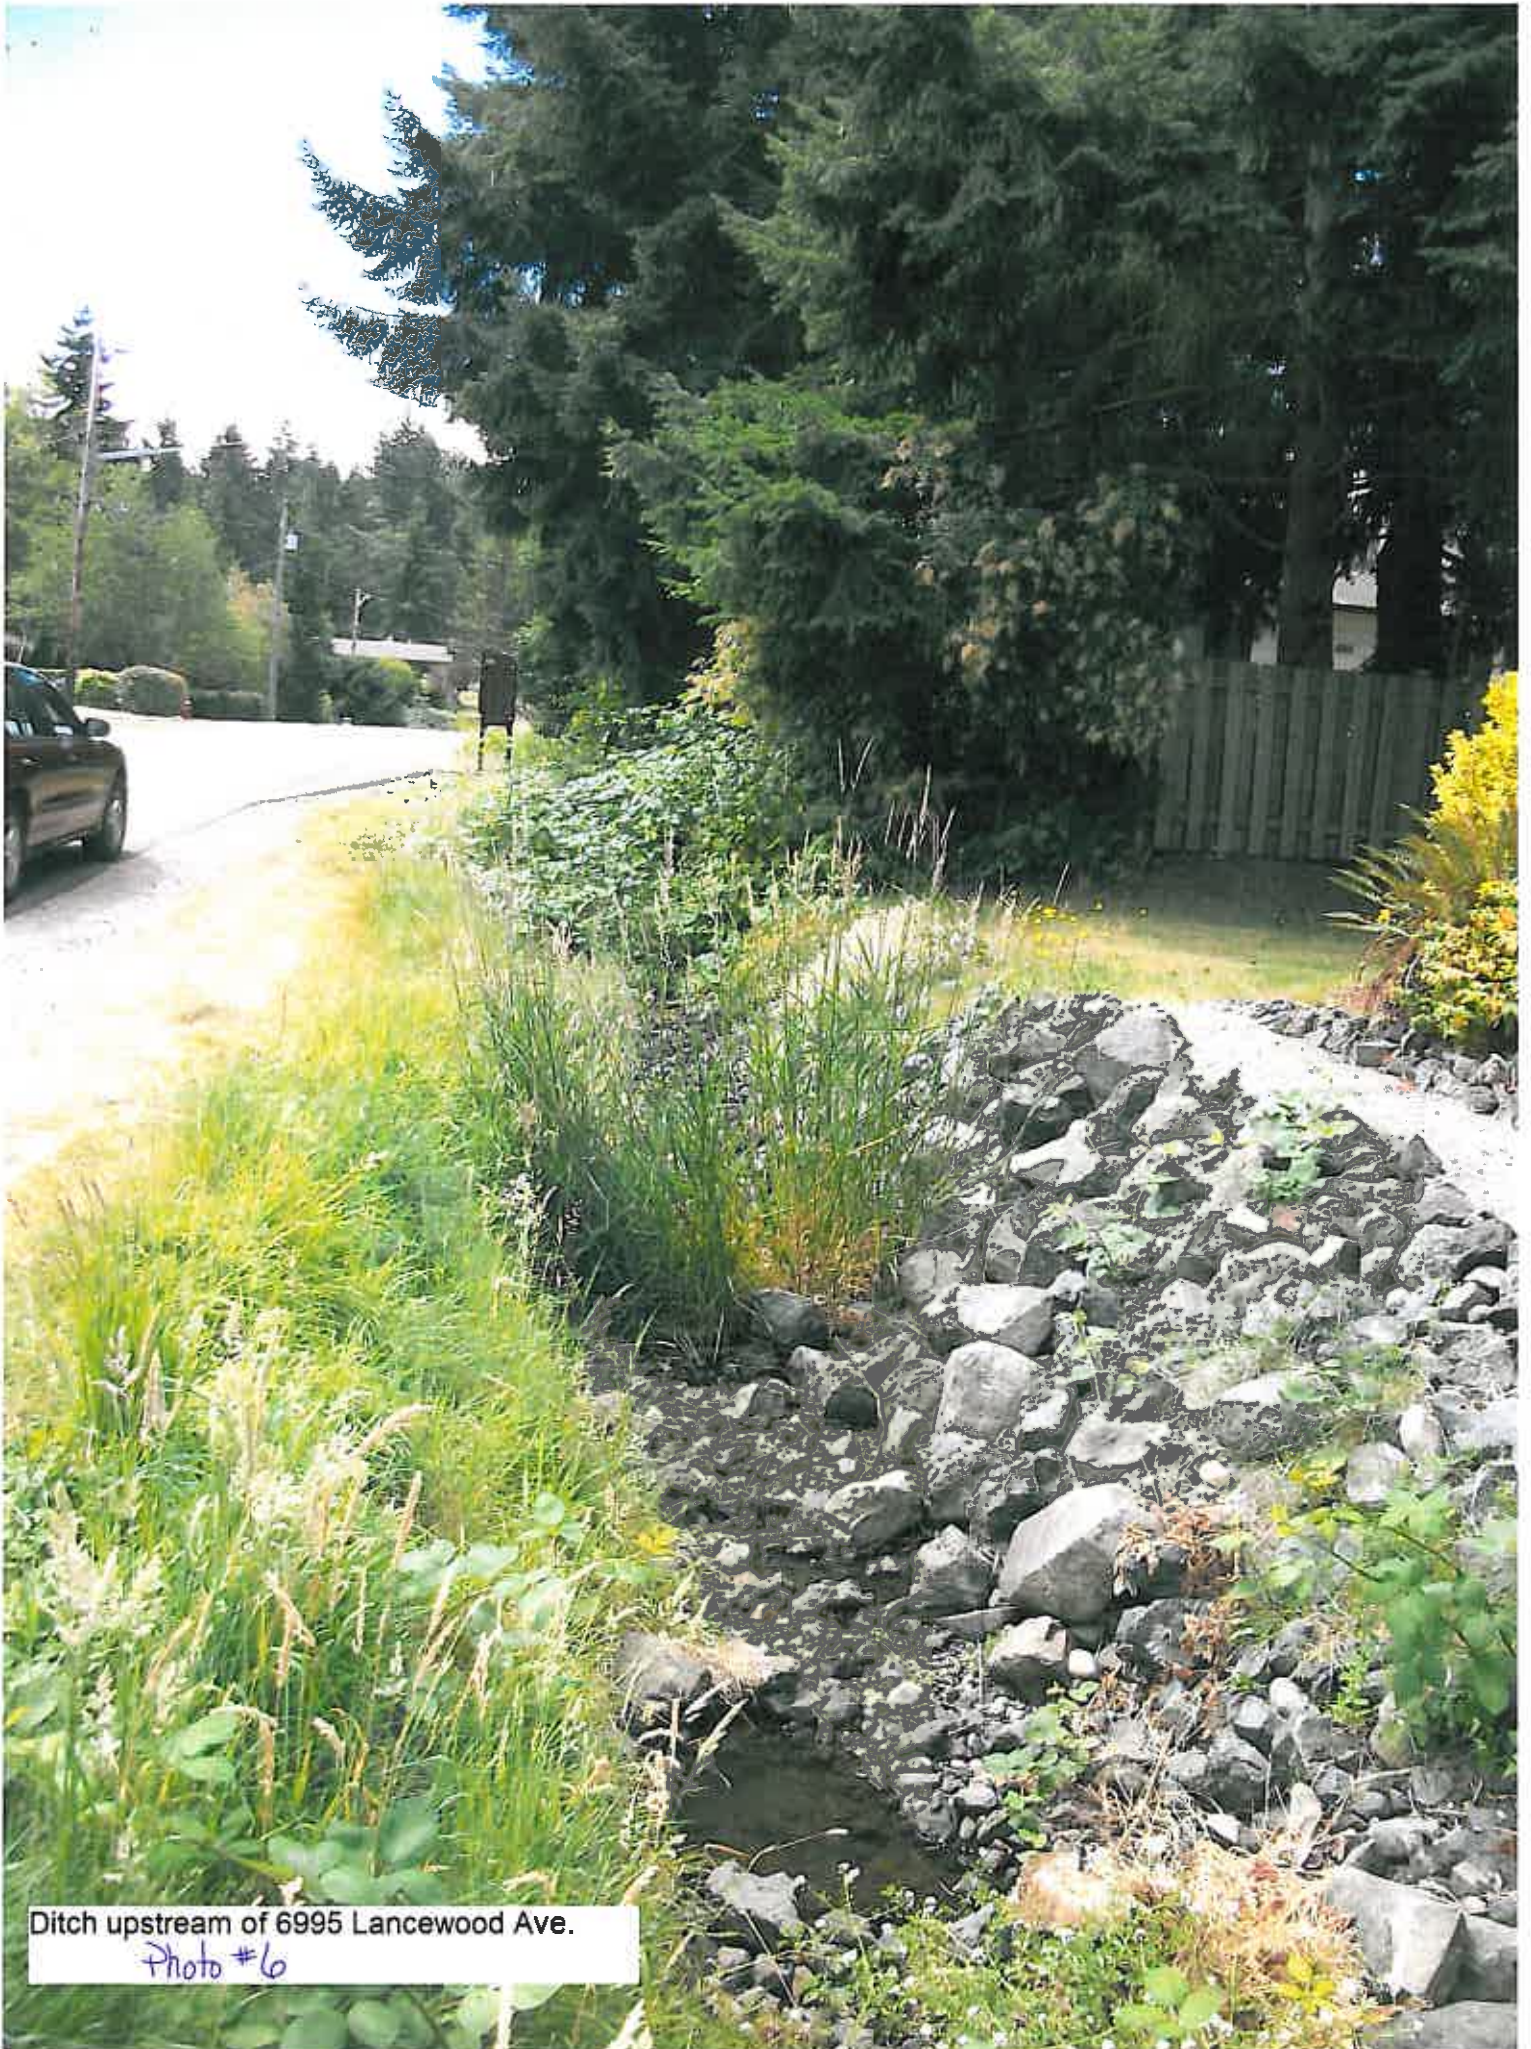
Photo #6

Ditch upstream of 6995 Lancewood Ave.
