Re: Lantzville Heritage Church, 7244 Lantzville Road – Code Compliance Review

Sorensen Trilogy Engineering has been requested to review the condition of Lantzville Heritage Church and to provide a general assessment of the building, including a seismic review. The assessment is based on a walk-through review of the structure. No destructive testing or investigative techniques were employed. The reference code is the 2018 British Columbia Building Code. The original report on this building was done in 2013 and this report encompasses that report and has been updated to reflect the new Building Code now in effect.

LANTZVILLE HERITAGE CHURCH
SEISMIC UPGRADE

**LANTZVILLE HERITAGE CHURCH
GRAVITY UPGRADE**

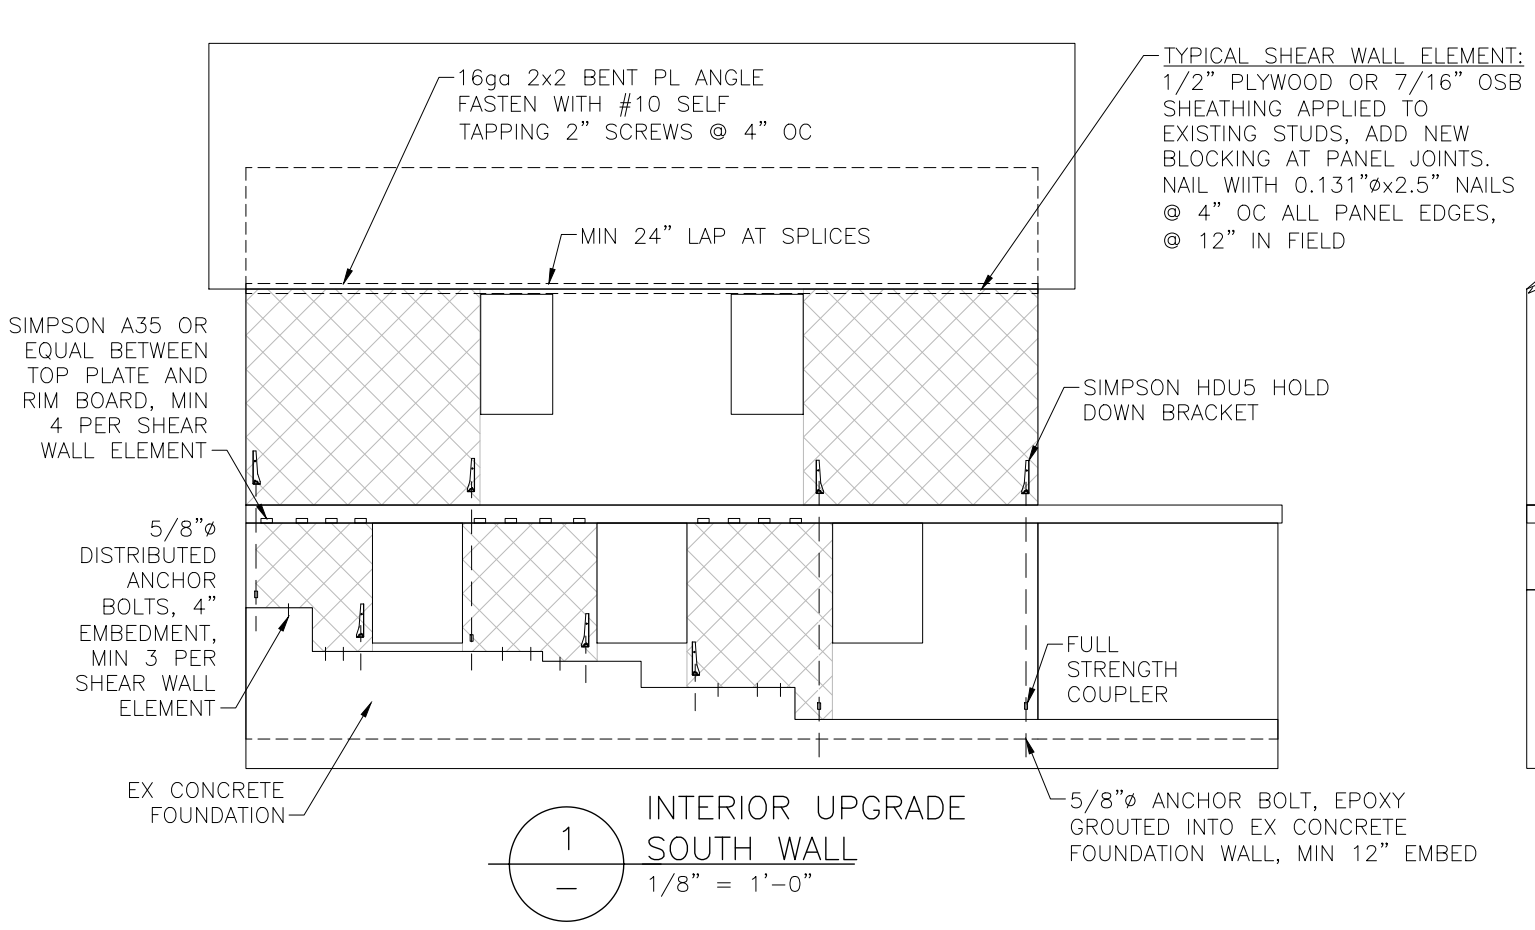
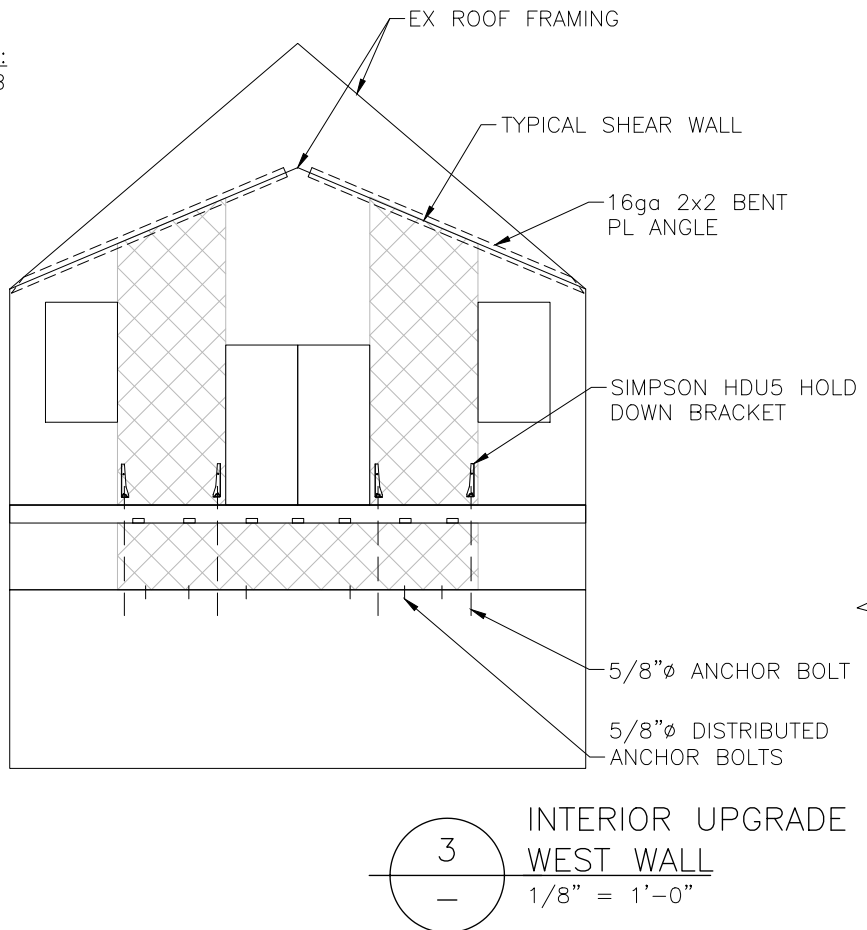
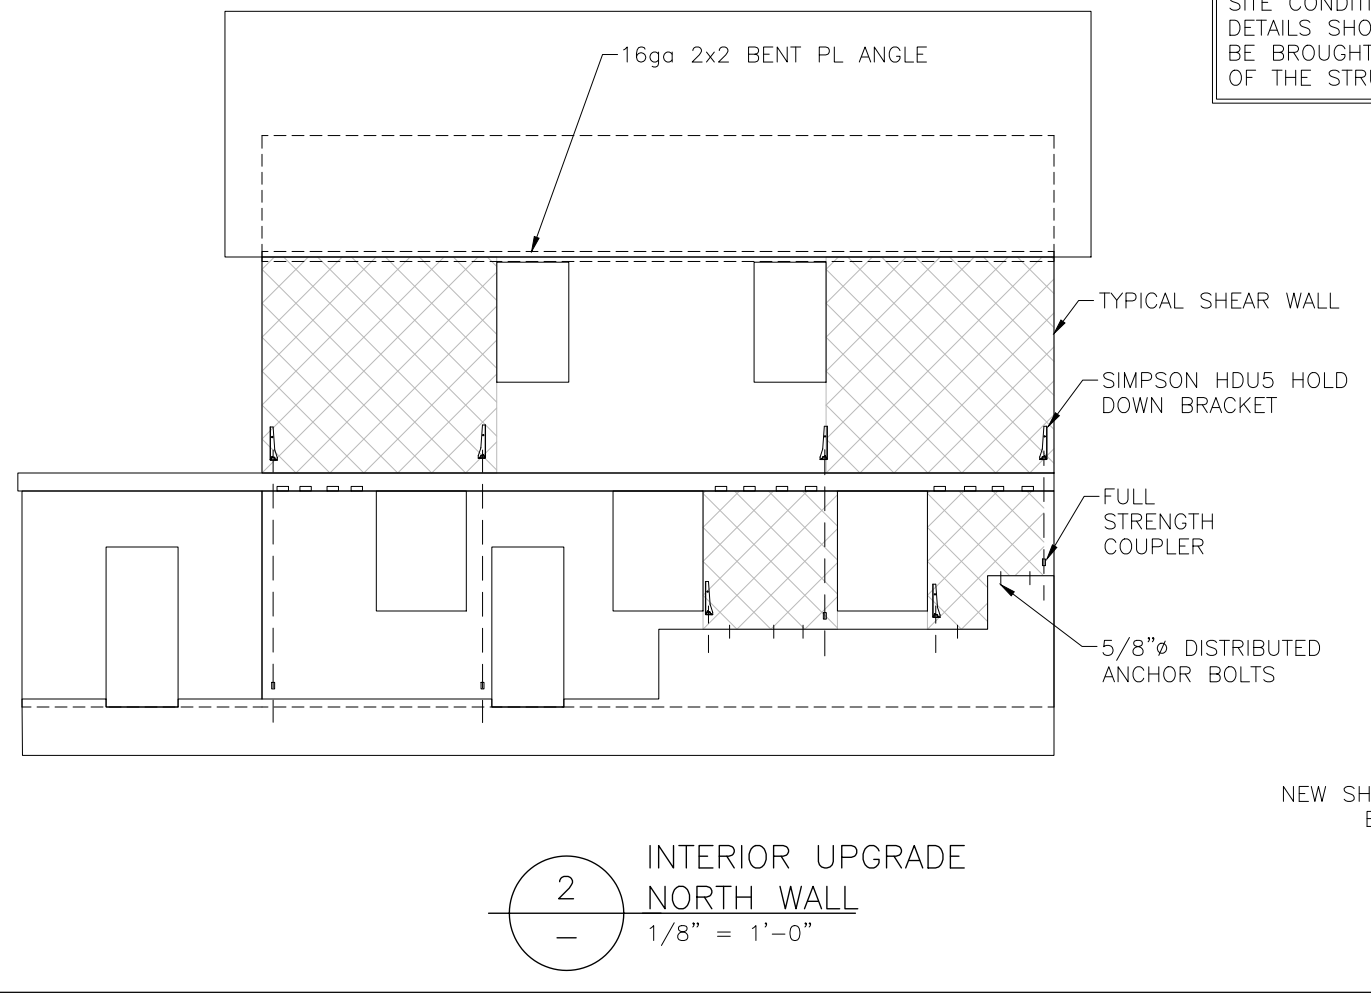
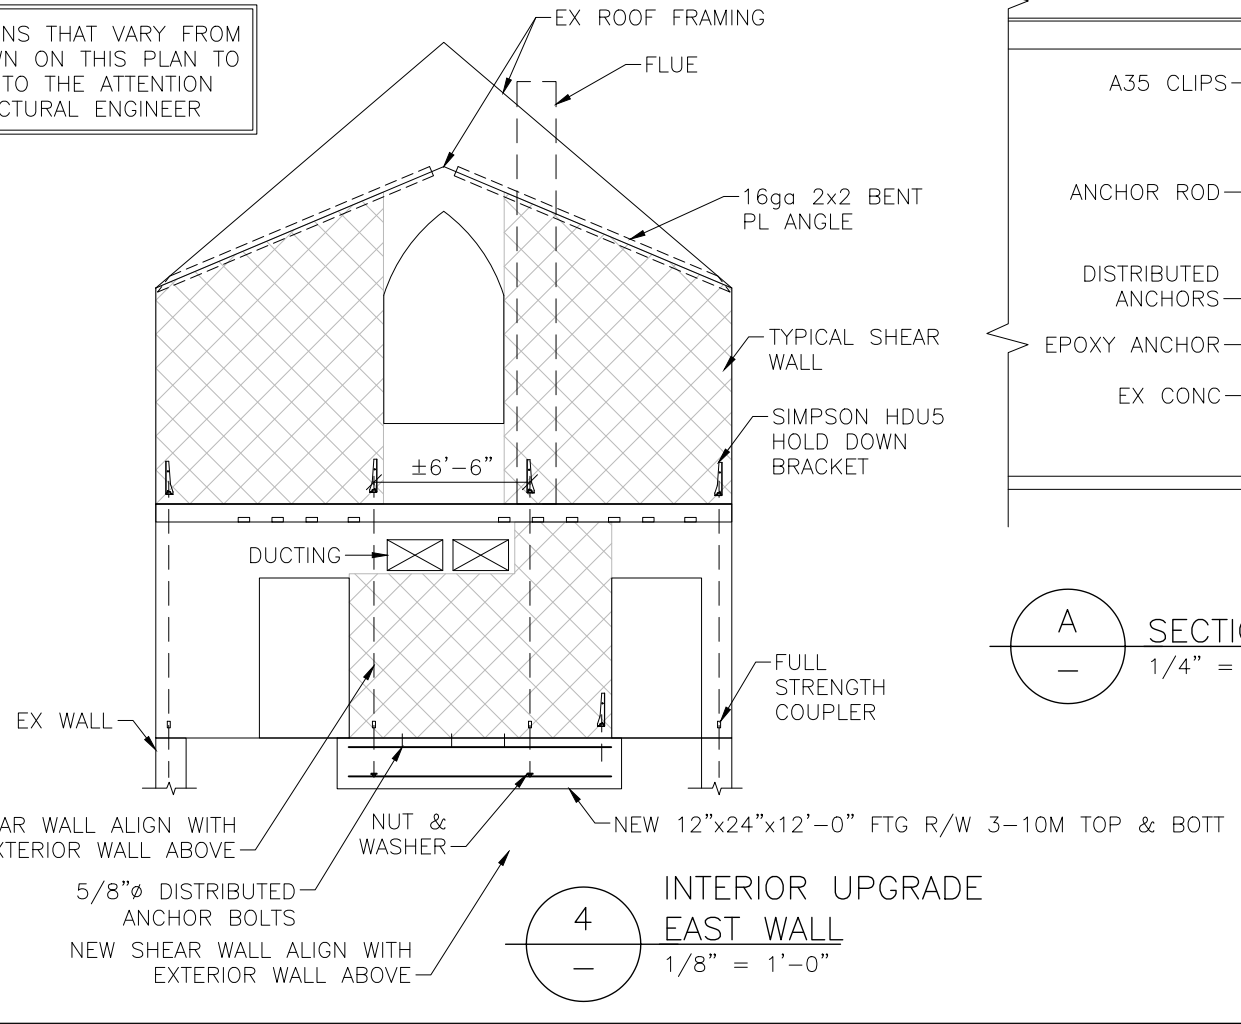
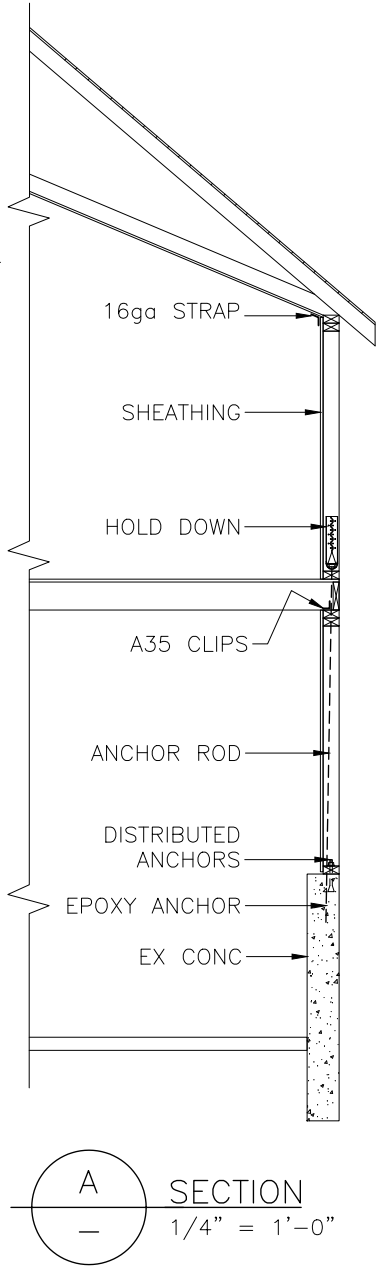
SEISMIC UPGRADE
BUILDING ELEVATIONS

The building is seismically deficient for current Building Code lateral load requirements. The most critical walls are the upper level front wall and the lower level rear wall. These two walls are more than four times weaker than the Building Code requires. The lower wall is of particular concern, because the wall is the weakest link in the entire structure at six times understrength. If a seismic upgrade is considered, details may have to be revised once the finishes are opened and actual conditions are verifiable.

The seismic upgrade for this building consists of installing wood panel shear walls, likely to the inside of the walls. The wood code allows the new plywood sheathing to be installed over the existing walls coverings. However, there is a requirement to access the floor space between floors and the stud space at the footing level, so it is probable that the interior finishes will have to be removed to complete the work. Straps between floors at the ends of the new shear wall elements must be installed. Anchors between the framing and the concrete foundations must be installed. Hold down rod elements will be required to be epoxy grouted into the existing concrete foundations to resist uplift forces. At the back wall of the church, a new footing is expected to be required, because the existing footing will likely be too small for the new imposed loads. A detailed upgrade scenario is appended to this report.

A seismic upgrade will require further study to determine the specific requirements of the upgrade. More invasive investigation will be required to provide the required information. In addition, the extent of upgrade must be determined. As a minimum, it is recommended that the lower rear wall be upgraded, so that the lateral loads from the upper building can be transferred down to the foundations. At that time, the connection between the walls and foundations should be assessed and upgraded if required.

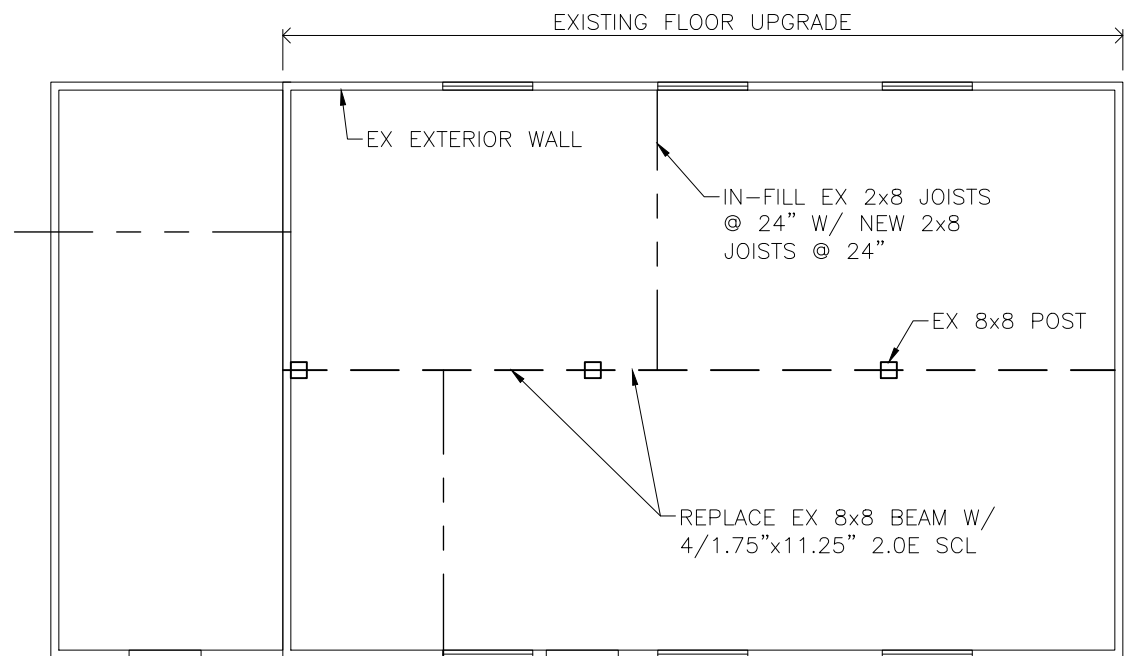
A
—
INTERIOR UPGRADE
MAIN FLOOR
1/8" = 1'-0"

The upper level of the church is considered an Assembly Occupancy. This means that the live load requirements are 100 psf. The joists are currently overstressed by about 100% in bending for this load requirement. The joists can meet code strength requirements for a live load of 40 psf. Deflection and vibration criteria are not met at this load level. To meet all of the Building Code requirements, the joist spacing would have to be decreased to 12" o/c.

The 8x8 beams are overstressed by more than 300% in bending for the longer spans and 180% in bending for the shorter span. The finding of code compliance of the beams and joists must be balanced with the fact that the structure is more than 80 years old and has performed adequately in that time. To be code compliant, the beams need to be replaced with 4 ply 1.75"x11.25" 2.0E SCL.
