GEOTECHNICAL HAZARD ASSESSMENT

7099 Lantzville Road, 6852 Wiles Road
Lantzville, BC

File No.: E3761.03

Lewkowich Engineering Associates Ltd.

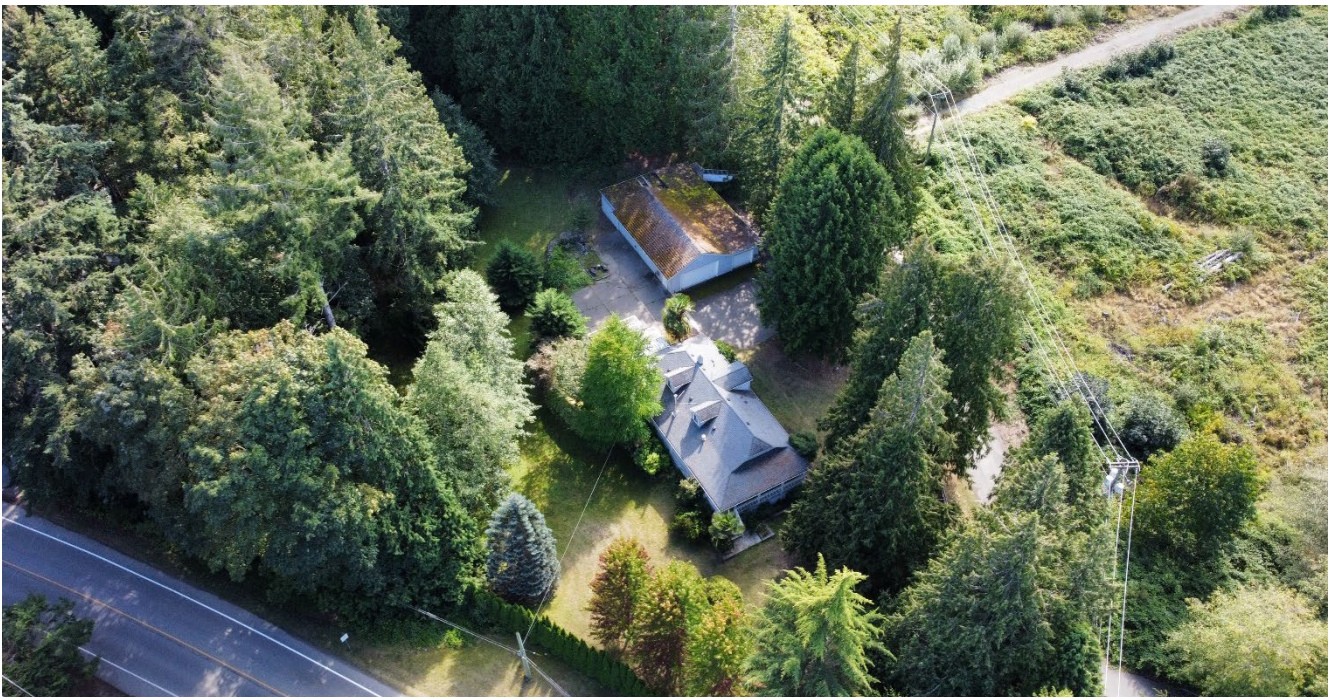
Photo 2.2.1 – Aerial view of 7099 Lantzville Road, looking southwest.

- c. Developed areas of 7099 Lantzville Road include typical residential lawn cover, landscaped areas, and gravel surfacing. The remainder of 7099 Lantzville Road and the majority of 6852 Wiles Road is forested with a light to moderate understory cover. Vegetation cover on the steep watercourse bank is generally poor due to the steep inclinations of the bank. Pistol butted trees are common along the slope face indicating small scale slope movements in surficial soils over time.

- d. We have reviewed air photos as early as 2004 and have not observed any indications of significant slope instability or failures.
- e. Refer to the following photos for general conditions across the Property.

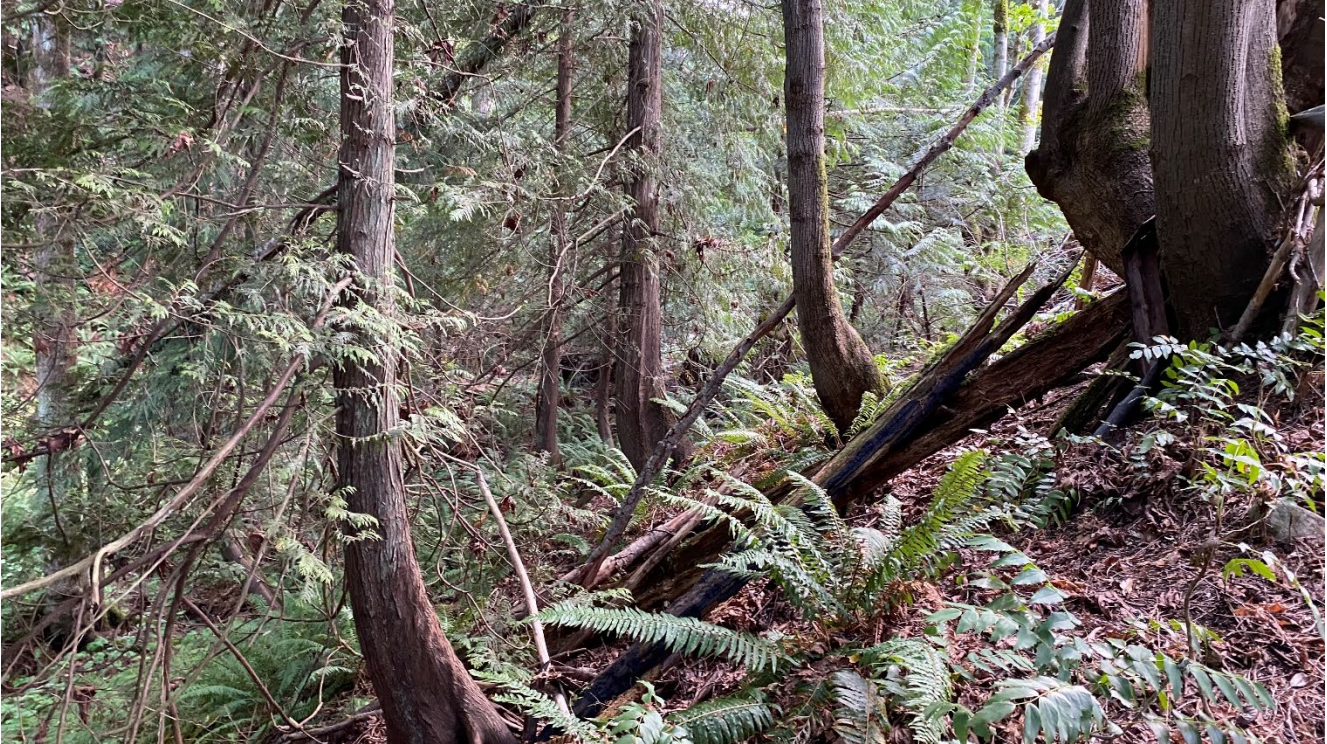
Photo 2.2.1 – Watercourse bank conditions on 6852 Wiles Road, looking south.

- a. There were varying degrees of watercourse channel erosion noted at the toe of the bank particularly where glacially consolidated sand and gravel materials were exposed along the natural boundary. These soils are susceptible to further erosion over the design life of future construction.

- b. The natural boundary of Bloods Creek includes frequent areas of exposed soil, and examples of undercutting of the toe of the bank. The rate of erosion, without historical monitoring of the PNB through survey data, is difficult to quantify. Based on our assessment and local experience, we recommend that an additional 5.0m be added to the slope setbacks as an allowance for bank erosion from the Bloods Creek watercourse over a 50-year design life for new construction.

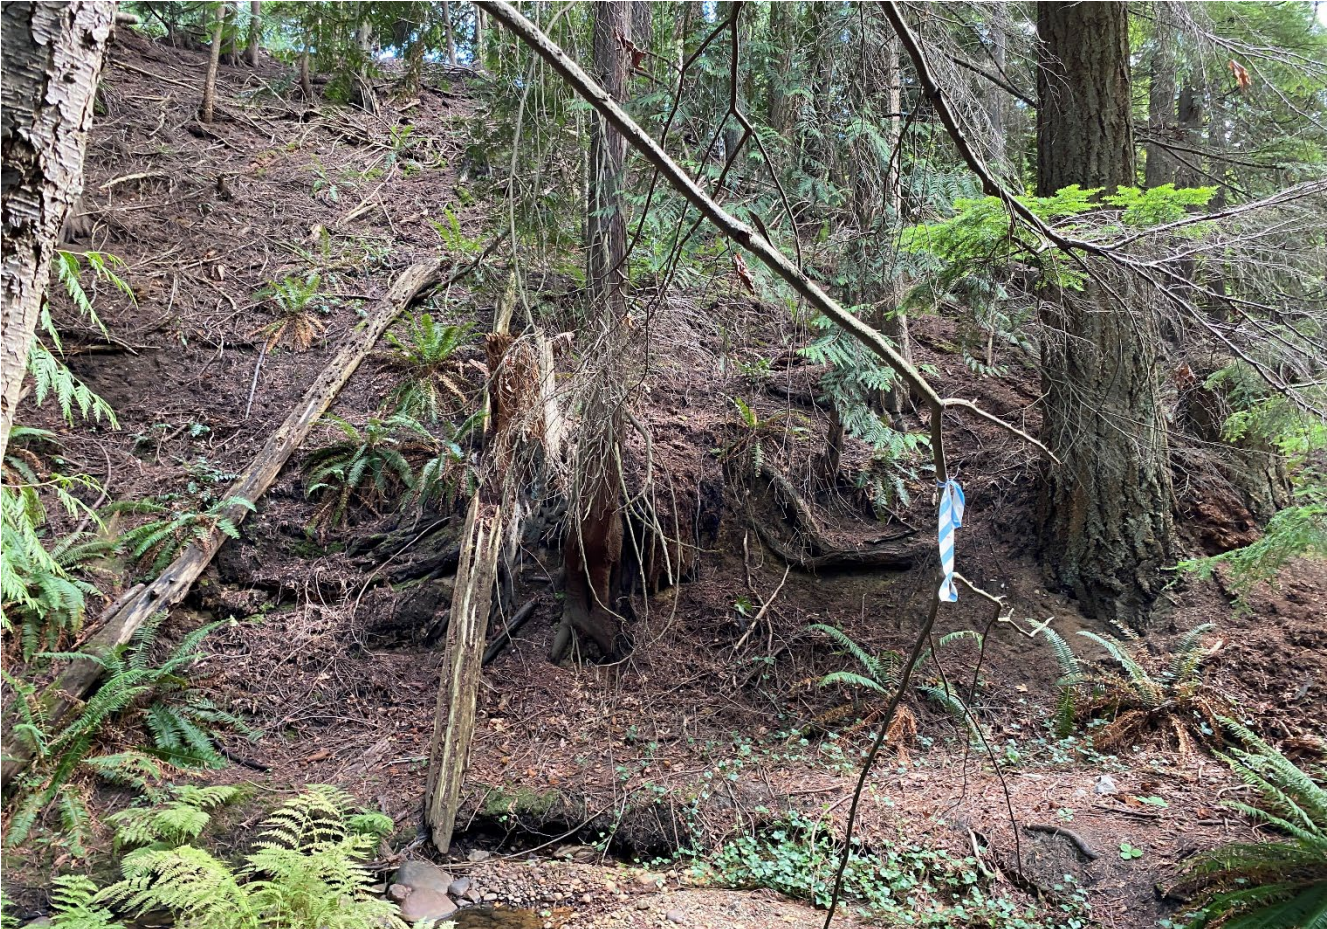
Photo 2.2.1 – Watercourse bank conditions on 6852 Wiles Road, looking west.

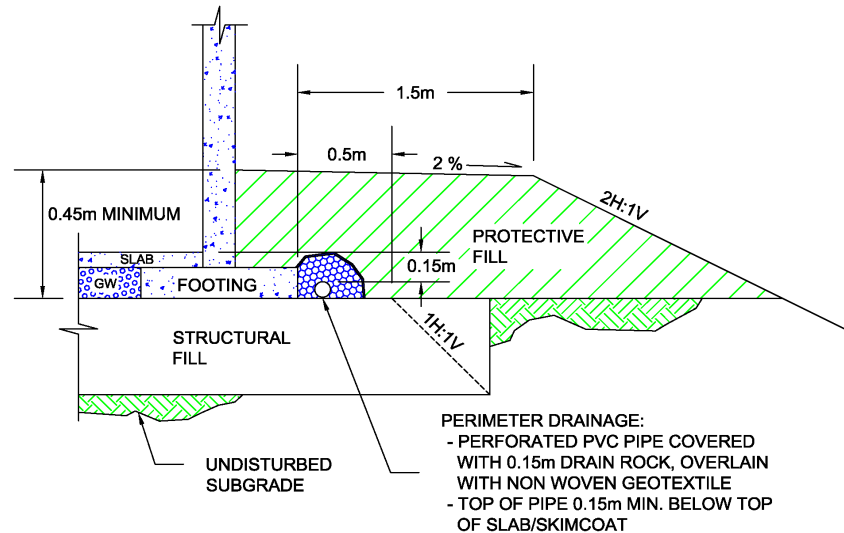
Figure 7.2 – Typical Section, Structural Fill

- e. Structural fills under foundations (including any isolated pad footings), roadways, and pavements should include the zone defined by a plane extending down and outward a minimum 0.5m from the outer edge of the foundation at an angle of 45 degrees from horizontal to ensure adequate subjacent support. This support zone is shown in Figure 7.2 below.

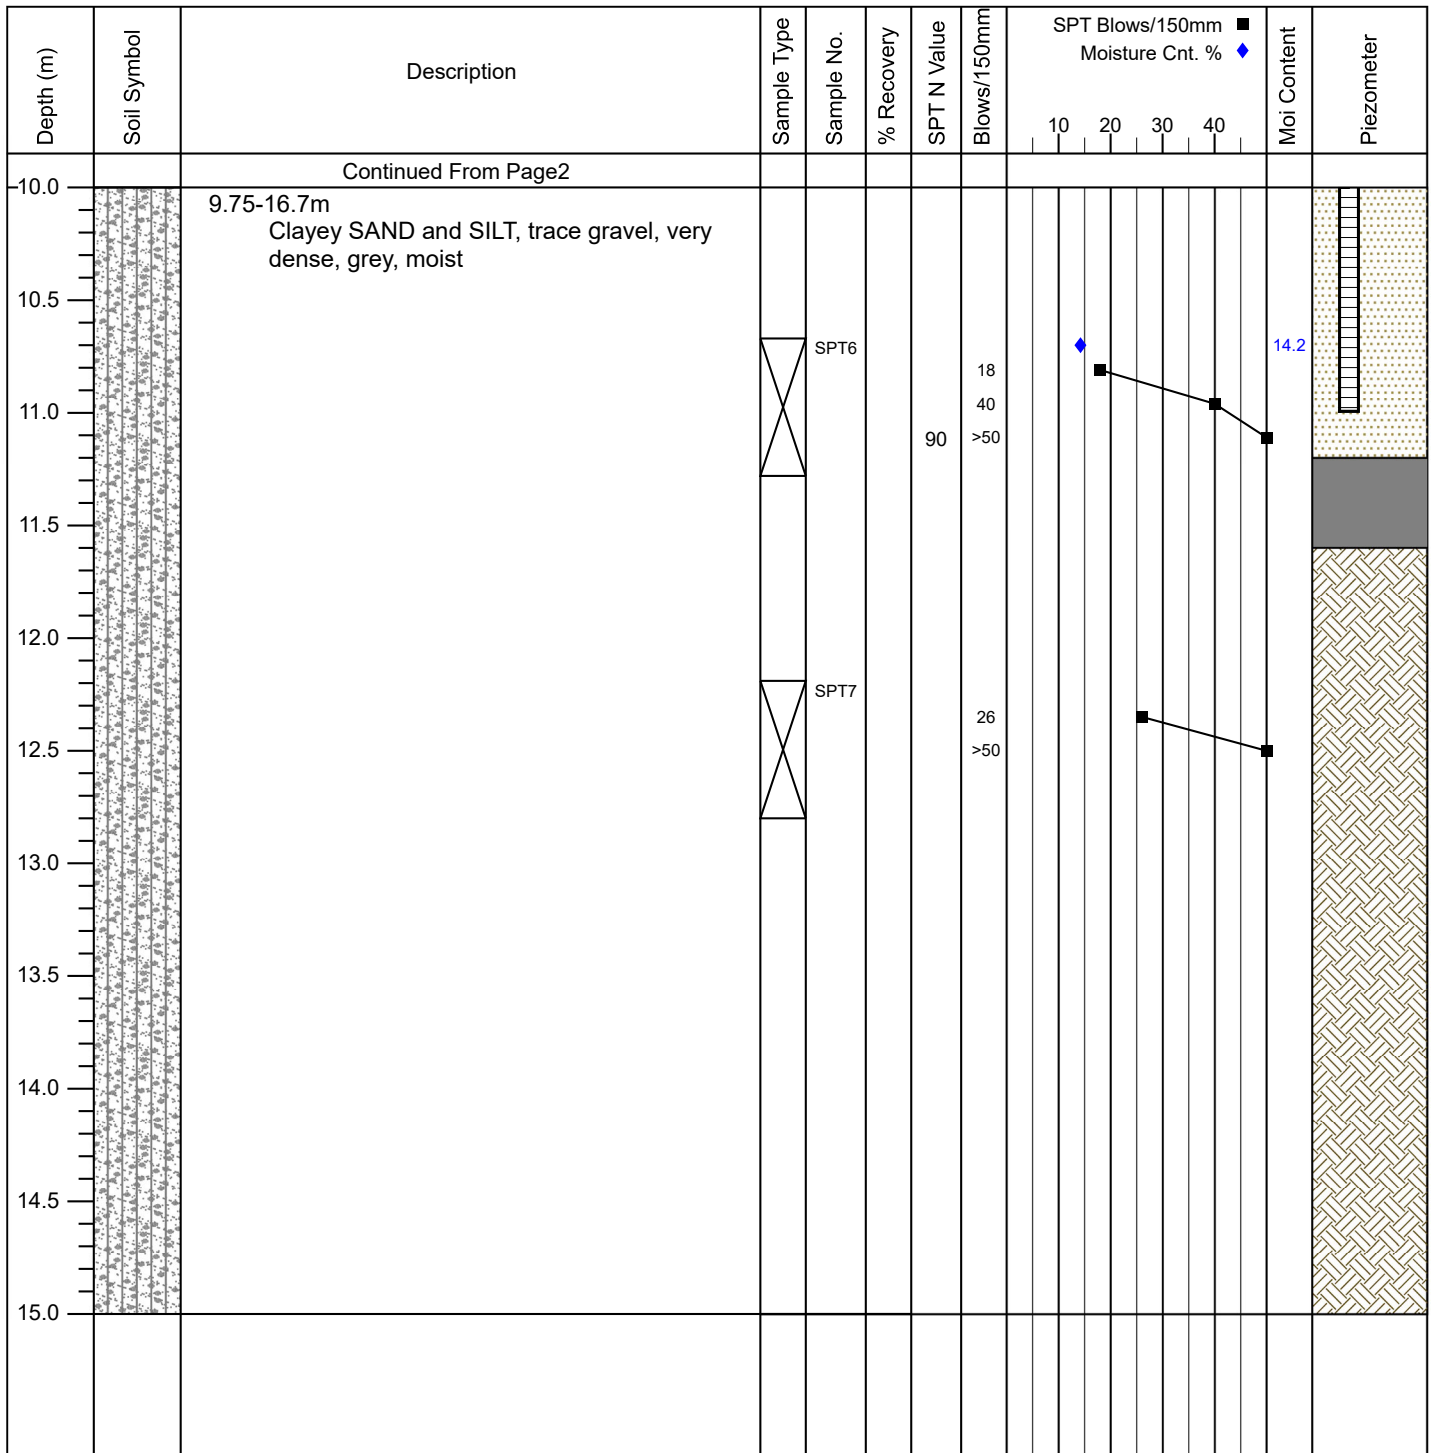
BH25-01

Logged By: Tennes Hamre, P.Geo. Date: July 29, 2025
 Reviewed By: Jeff Scott, P.Eng. Page 3 of 4
 Digging Method: Boart LS250 Sonic Drill

- a. Relatively consistent soil strata were encountered during the subsurface investigation. The main soil strata are summarized in Table 2.4.1 and 2.4.2 below. Detailed descriptions of the subsurface conditions are provided on the attached BH logs (BH25-01 to BH25-03).

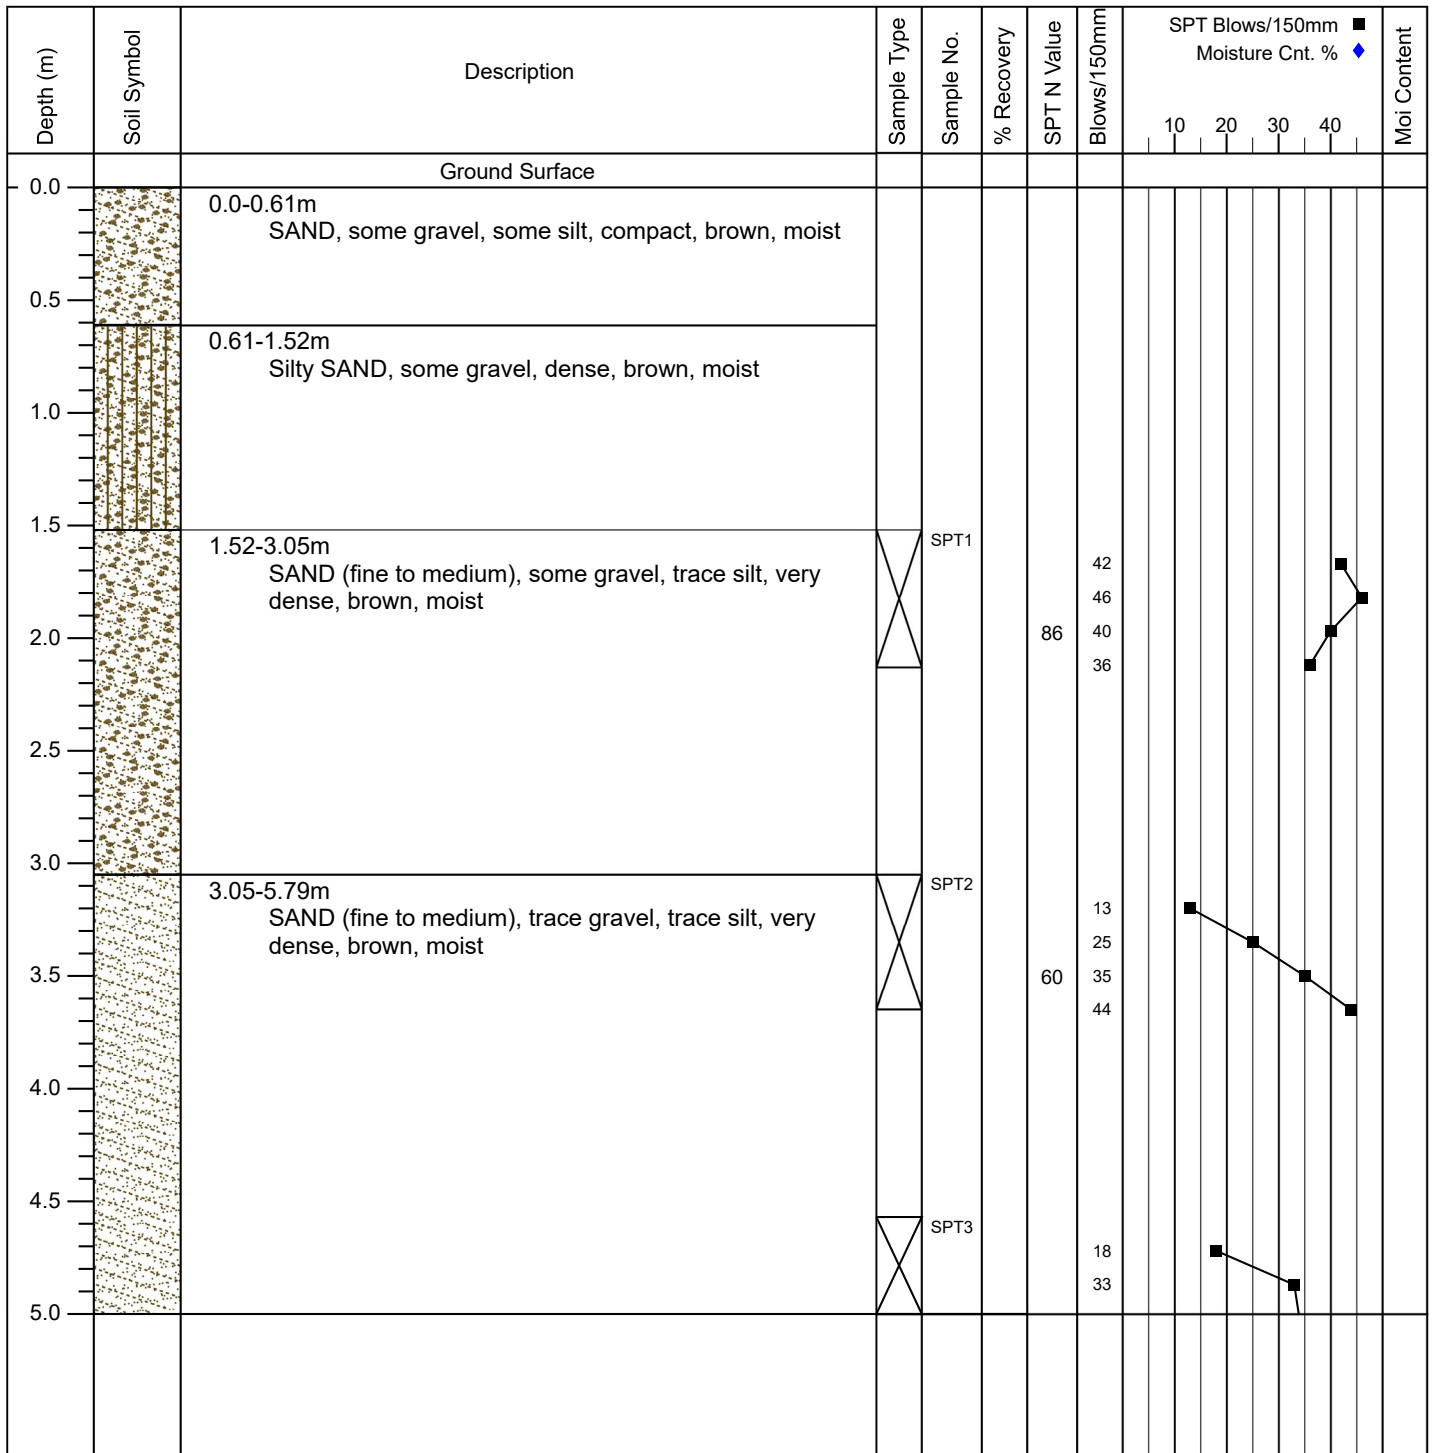
BH25-02

Logged By: Tennes Hamre, P.Geo. Reviewed By: Jeff Scott, P.Eng. Digging Method: Boart LS250 Sonic Drill	Date: July 29, 2025 Page 1 of 3	1900 Boxwood Road Nanaimo, BC, V9S 5Y2 Phone: 250-756-0355 Fax: Email: geotech@lewkovich.com
---	------------------------------------	--

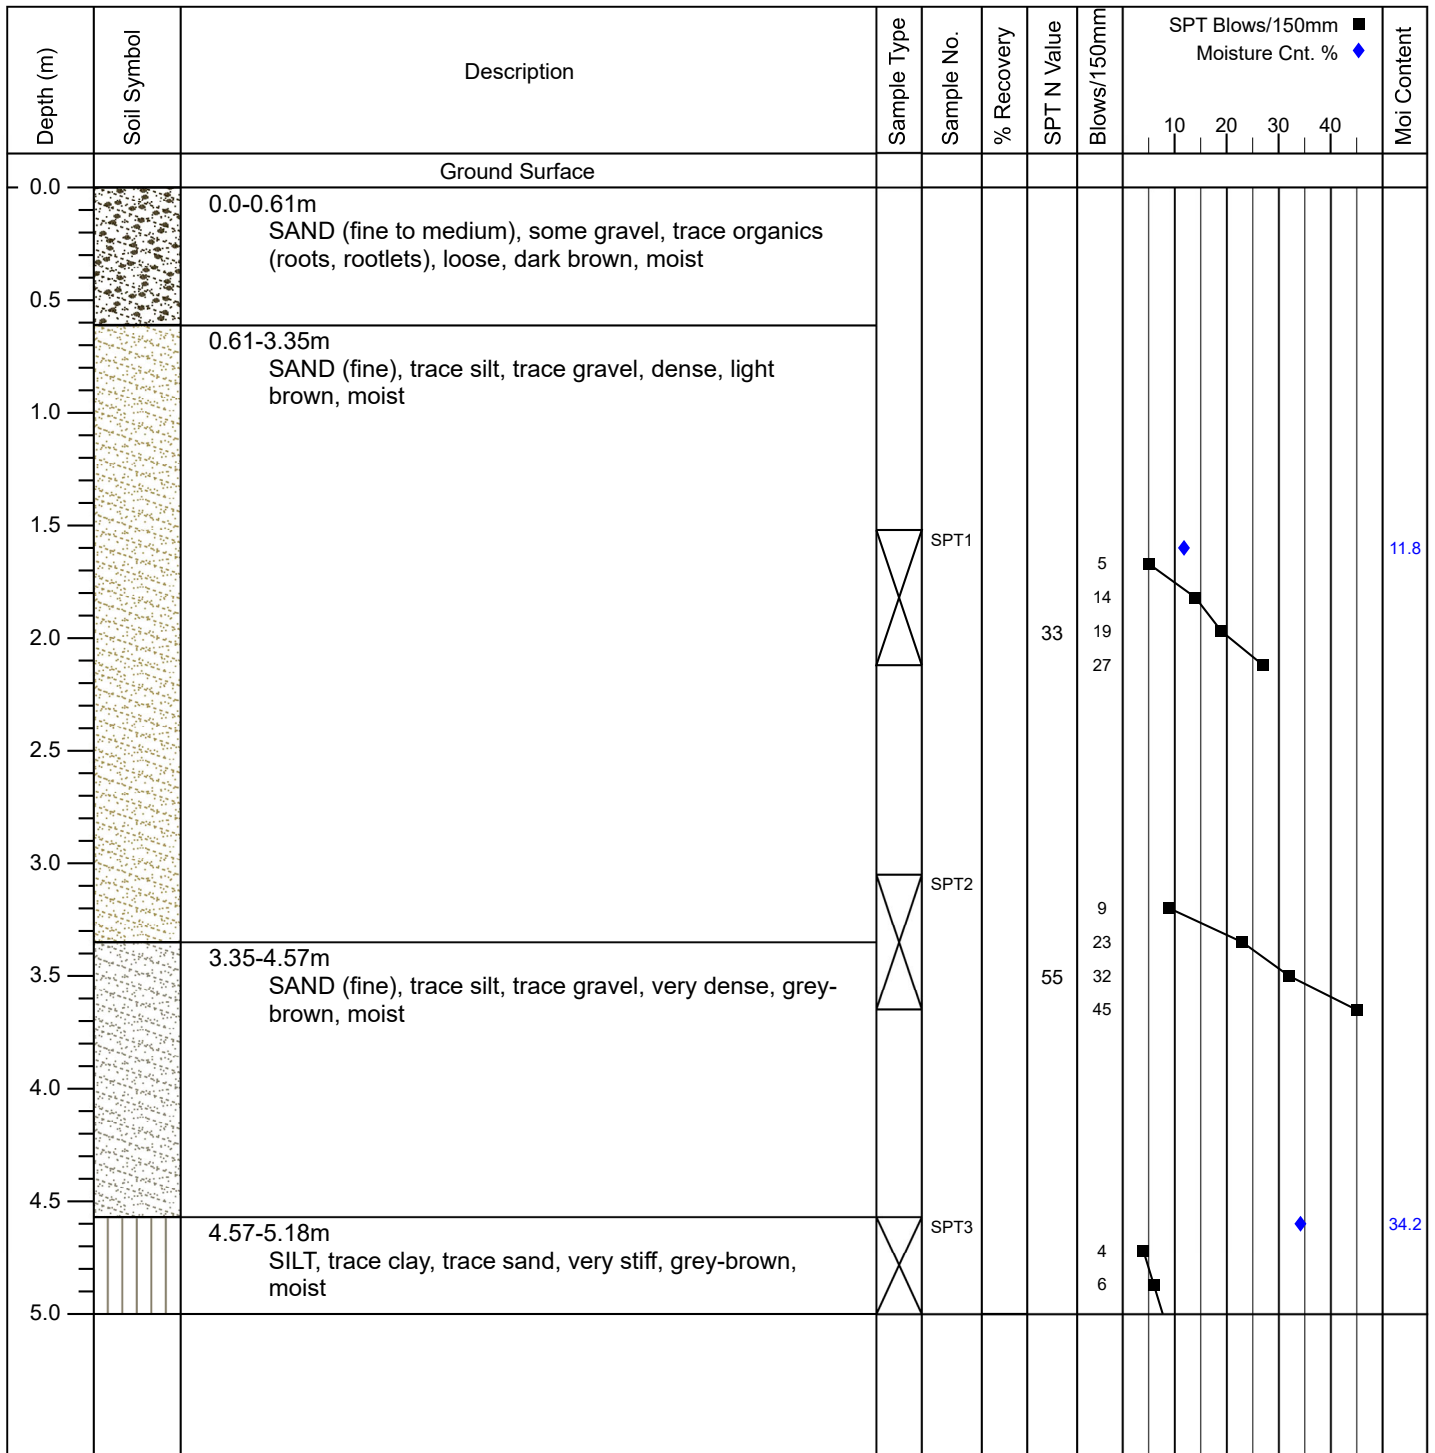
BH25-03

Logged By: Tennes Hamre, P.Geo. Date: July 29, 2025
 Reviewed By: Jeff Scott, P.Eng. Page 1 of 2
 Digging Method: Boart LS250 Sonic Drill

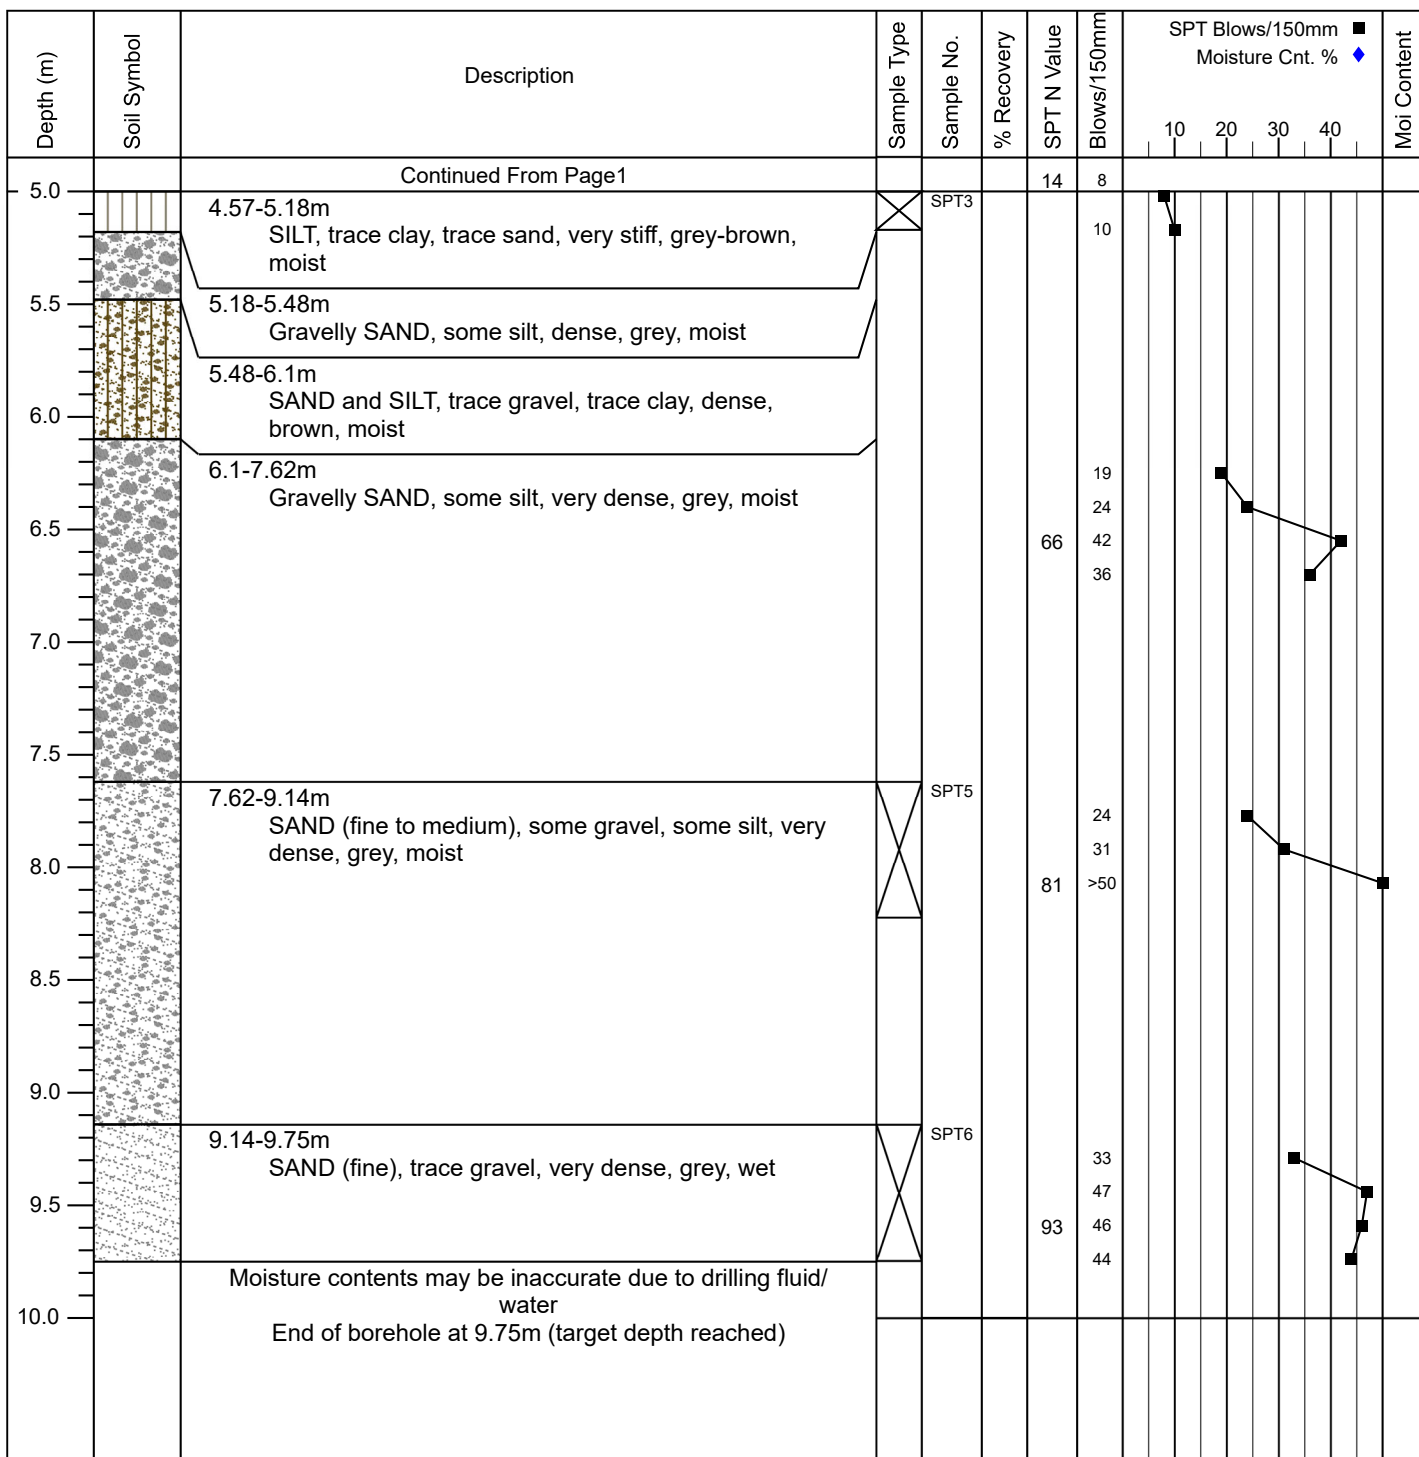
BH25-03

Logged By: Tennes Hamre, P.Geo. Reviewed By: Jeff Scott, P.Eng. Digging Method: Boart LS250 Sonic Drill	Date: July 29, 2025 Page 2 of 2	1900 Boxwood Road Nanaimo, BC, V9S 5Y2 Phone: 250-756-0355 Fax: Email: geotech@lewkovich.com
---	------------------------------------	--

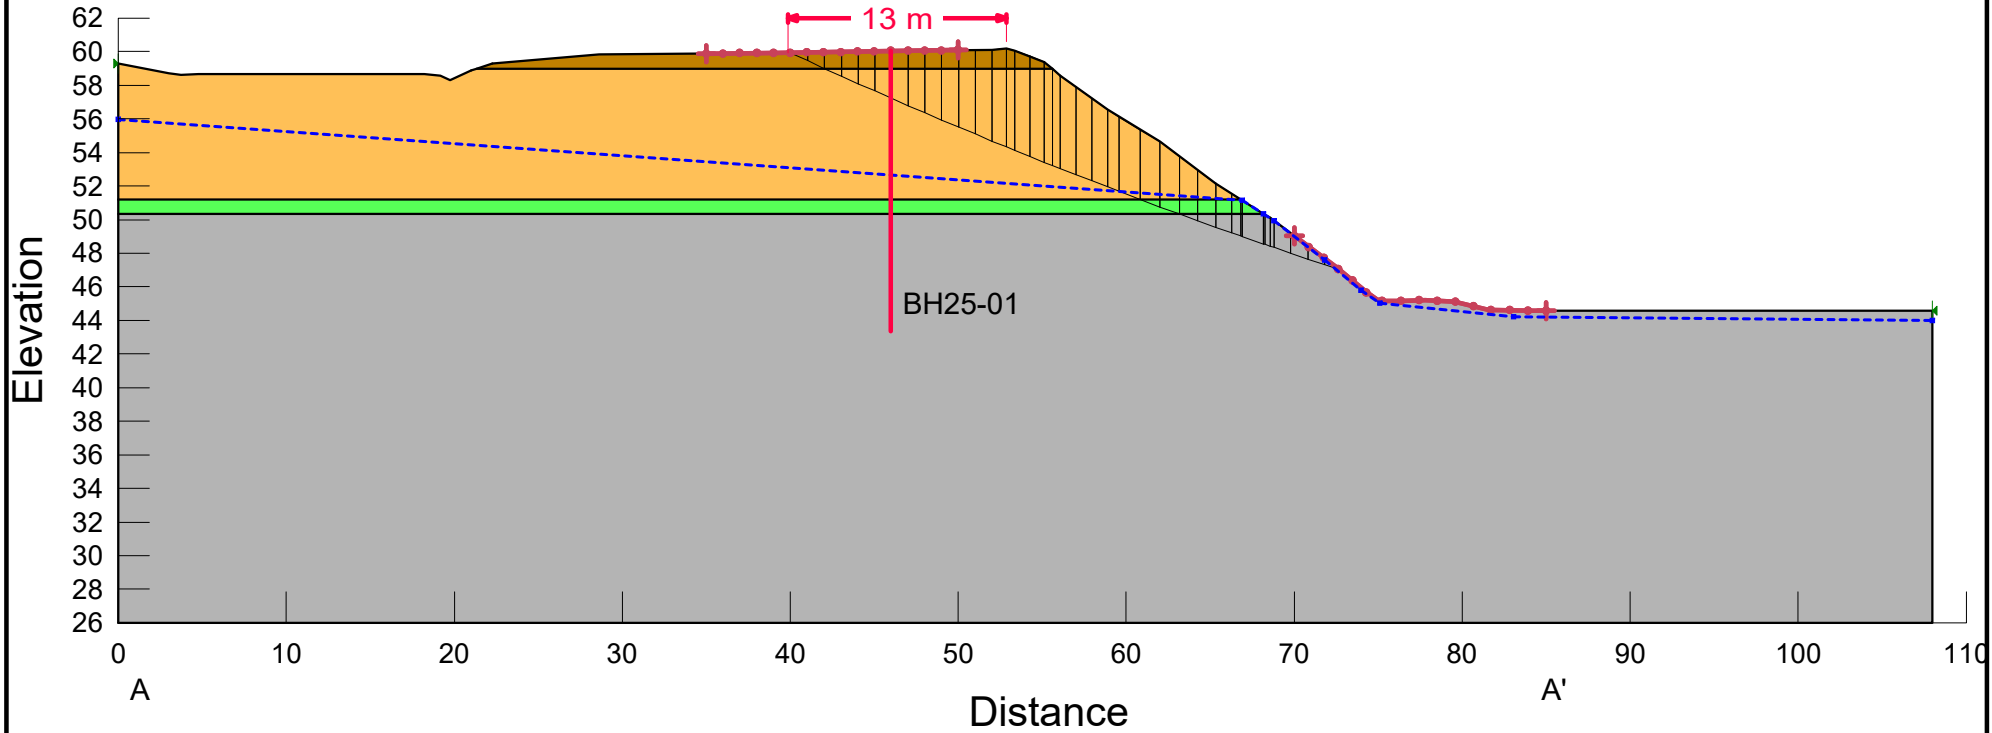
E3761
 Section A-A'
 2% in 50 year Seismic
 Horiz. Seismic Coeff: 0.274

Color	Name	Slope Stability Material Model	Unit Weight (kN/m ³)	Effective Cohesion (kPa)	Effective Friction Angle (°)	Piezometric Surface
■	01 - Gravelly sand, compact, brown, moist	Mohr-Coulomb	20	0	34	
■	02 - Sand and Gravel, trace silt, very dense, brown, moist to wet	Mohr-Coulomb	21	0	38	1
■	03 - Silt, some sand, very stiff, grey, moist	Mohr-Coulomb	21	0	30	1
■	04 Clayey sand and silt, very dense, grey, moist	Mohr-Coulomb	22	0	40

- a. The results of the slope stability analysis and seismic slope displacement calculations are summarized in Tables 4.5.1 and 4.5.2 below. Detailed Slope/W plots can also be found attached to this Report. The Slope/W plots display computed slip surfaces that have a FoS less than the minimum target value.
- b. Table 4.5.1 below summarizes the minimum setbacks from crest of slope that are required to satisfy the design FoS for each condition.

Section	Failure Scenario	Condition	Setback from Crest of Slope (m)
Section A-A'	Rotational Failure	Static	7.0m
Section A-A'	Rotational Failure	Seismic	13.0m
Section B-B'	Rotational Failure	Static	5.5m
Section B-B'	Rotational Failure	Seismic	8.5m

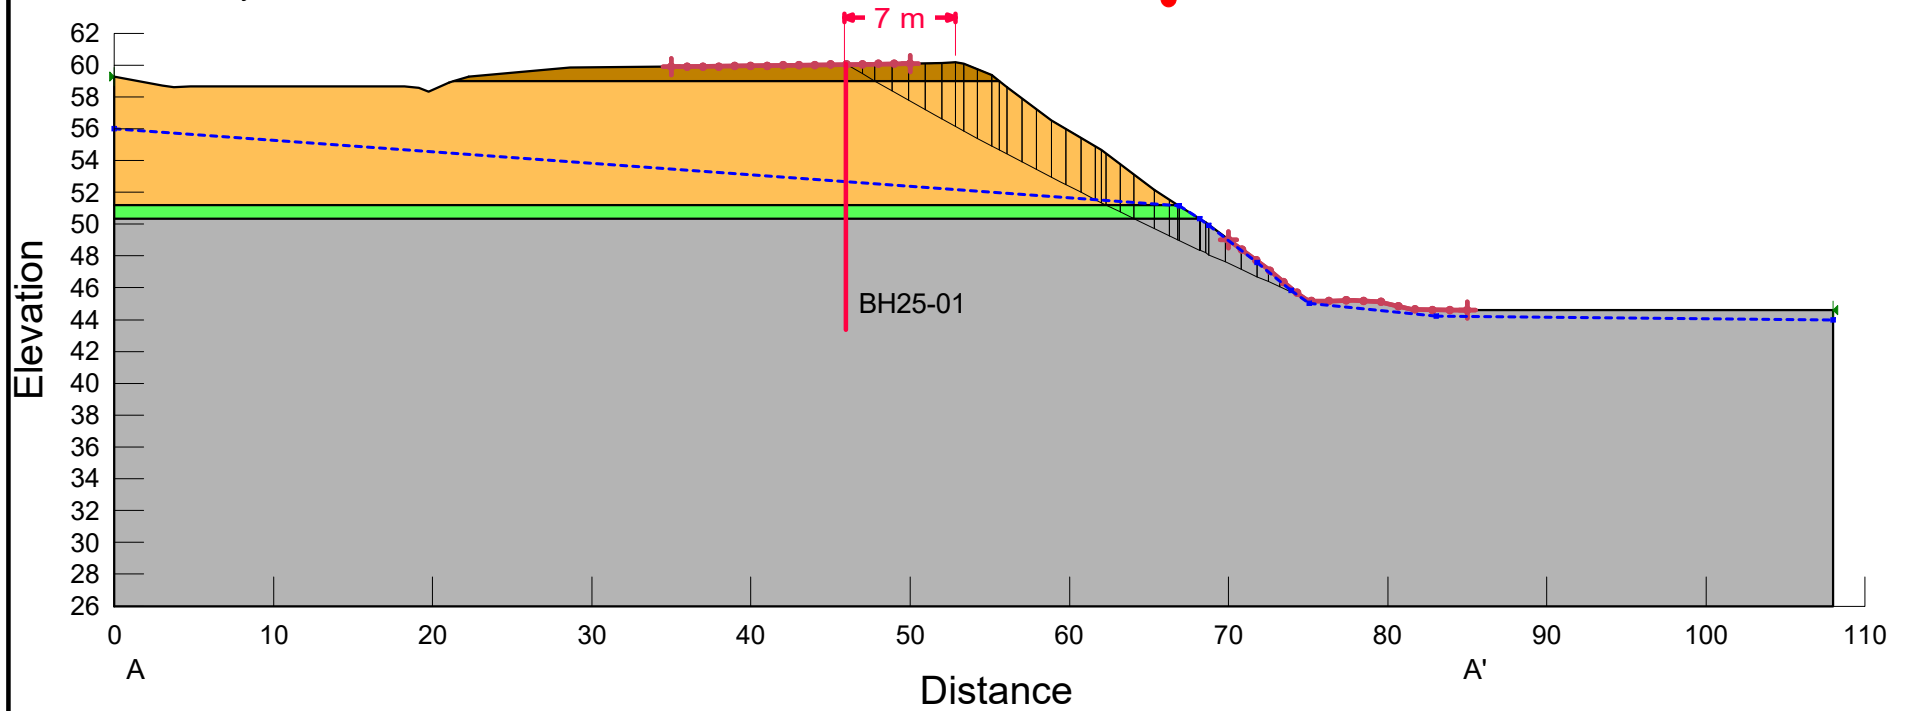
E3761
 Section A-A'
 2% in 50 year Static

Color	Name	Slope Stability Material Model	Unit Weight (kN/m ³)	Effective Cohesion (kPa)	Effective Friction Angle (°)	Piezometric Surface
■	01 - Gravelly sand, compact, brown, moist	Mohr-Coulomb	20	0	34	
■	02 - Sand and Gravel, trace silt, very dense, brown, moist to wet	Mohr-Coulomb	21	0	38	1
■	03 - Silt, some sand, very stiff, grey, moist	Mohr-Coulomb	21	0	30	1
■	04 Clayey sand and silt, very dense, grey, moist	Mohr-Coulomb	22	0	40

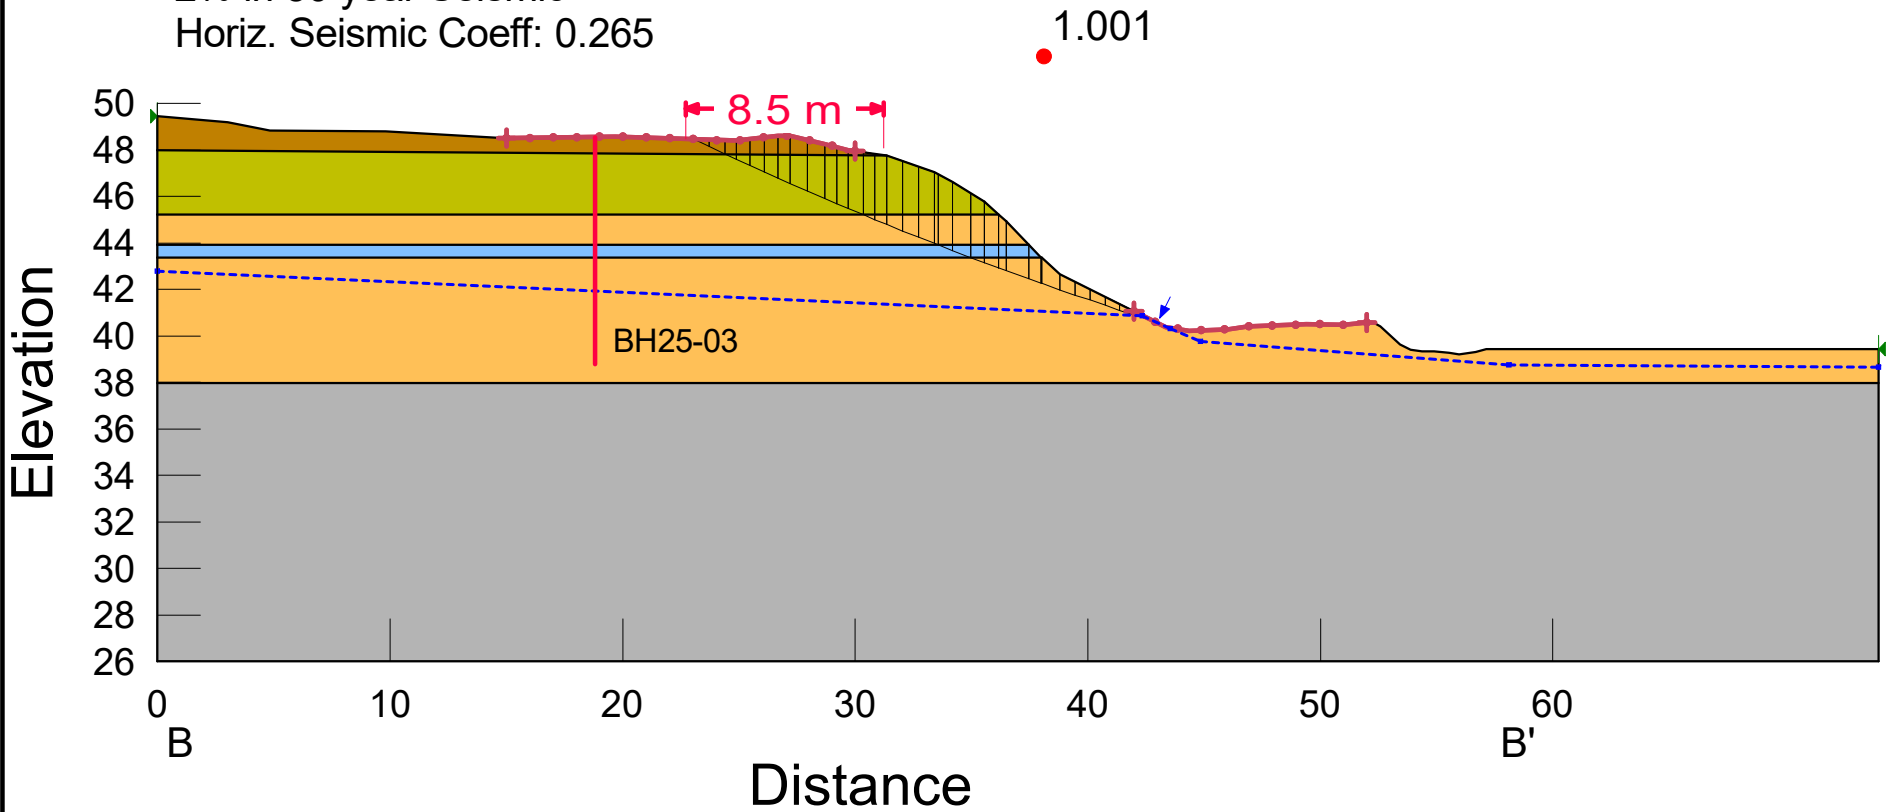
E3761
 Section B-B'
 2% in 50 year Seismic
 Horiz. Seismic Coeff: 0.265

Color	Name	Slope Stability Material Model	Unit Weight (kN/m ³)	Effective Cohesion (kPa)	Effective Friction Angle (°)	Piezometric Surface
■	01 - Gravelly sand, compact, brown, moist	Mohr-Coulomb	20	0	34	
■	01b - Sand, trace silt, trace gravel, dense, moist	Mohr-Coulomb	21	0	36	
■	02 - Sand and Gravel, trace silt, very dense, brown, moist to wet	Mohr-Coulomb	21	0	38	1
■	03b - Silt, trace clay and sand, stiff, grey-brown	Mohr-Coulomb	21	0	28	
■	04 Clayey sand and silt, very dense, grey, moist	Mohr-Coulomb	22	0	40

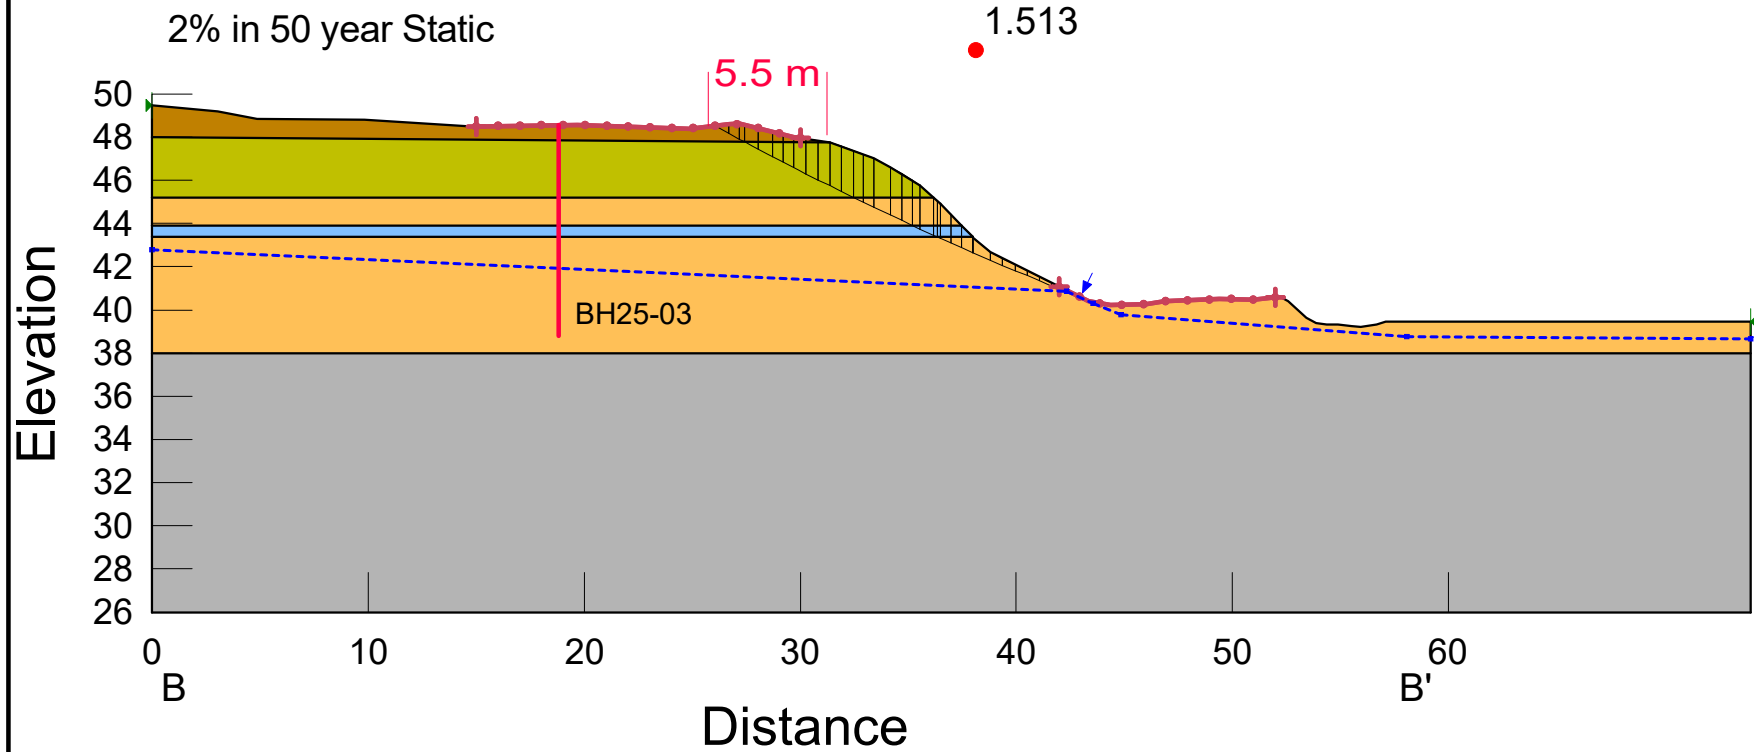
E3761
 Section B-B'
 2% in 50 year Static

Color	Name	Slope Stability Material Model	Unit Weight (kN/m ³)	Effective Cohesion (kPa)	Effective Friction Angle (°)	Piezometric Surface
■	01 - Gravelly sand, compact, brown, moist	Mohr-Coulomb	20	0	34	
■	01b - Sand, trace silt, trace gravel, dense, moist	Mohr-Coulomb	21	0	36	
■	02 - Sand and Gravel, trace silt, very dense, brown, moist to wet	Mohr-Coulomb	21	0	38	1
■	03b - Silt, trace clay and sand, stiff, grey-brown	Mohr-Coulomb	21	0	28	
■	04 Clayey sand and silt, very dense, grey, moist	Mohr-Coulomb	22	0	40

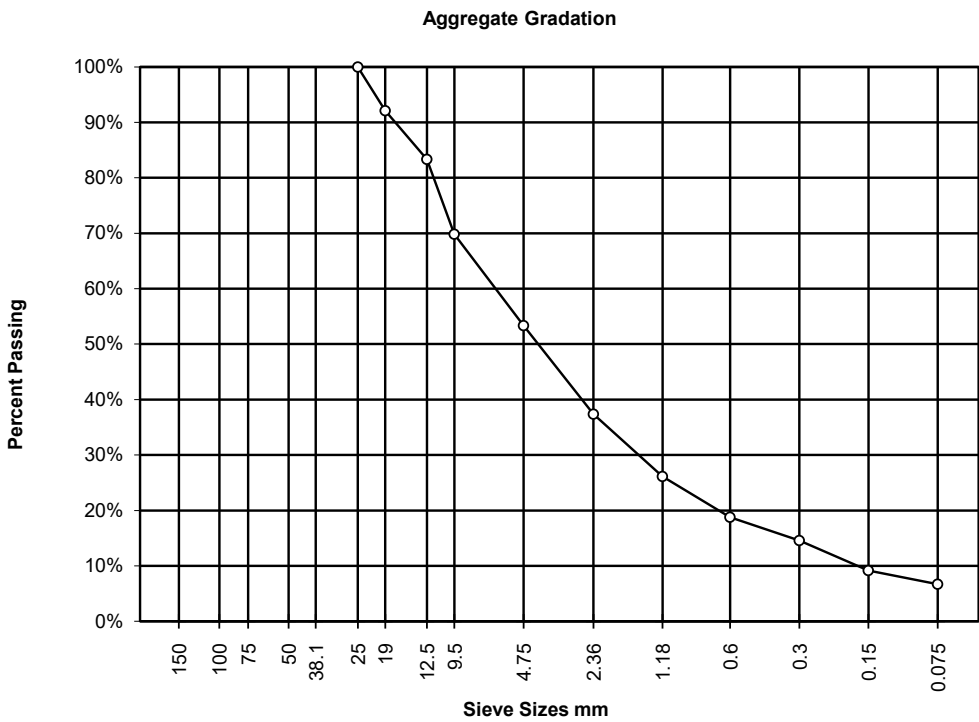
Classification Description: Well Graded Gravel with silt and sand

Aggregate Gradation		Specified Limits	
Sieve Sizes mm	Percent Passing	Minimum	Maximum
150			
100			
75			
50			
38.1			
25	100%		
19	92%		
12.5	83%		
9.5	70%		
4.75	53%		
2.36	37%		
1.18	26%		
0.6	19%		
0.3	15%		
0.15	9%		
0.075	6.7%

As Received Moisture Content = 7.8%

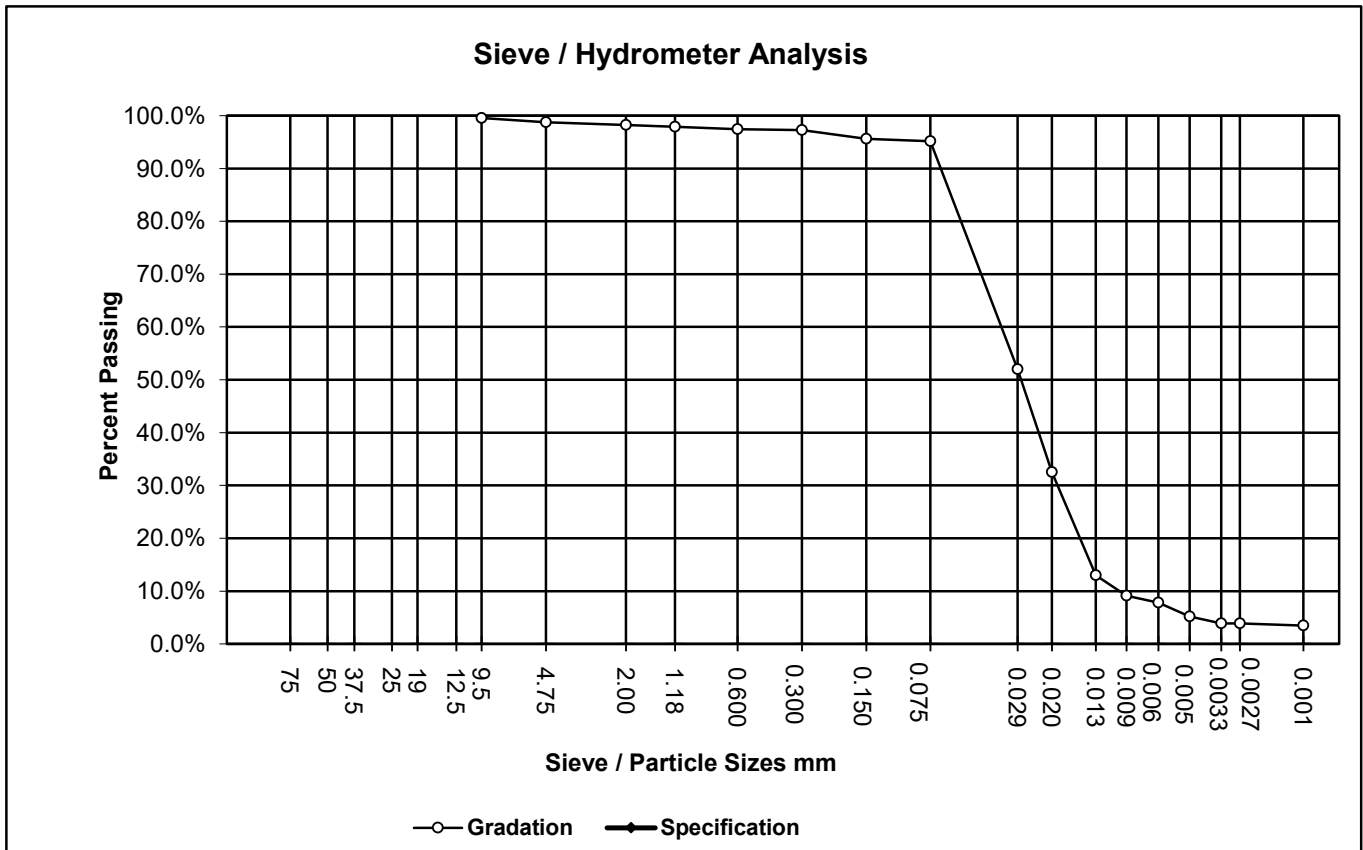
Clay Sizes: < 0.002mm

As Received Moisture Content = 34.2%

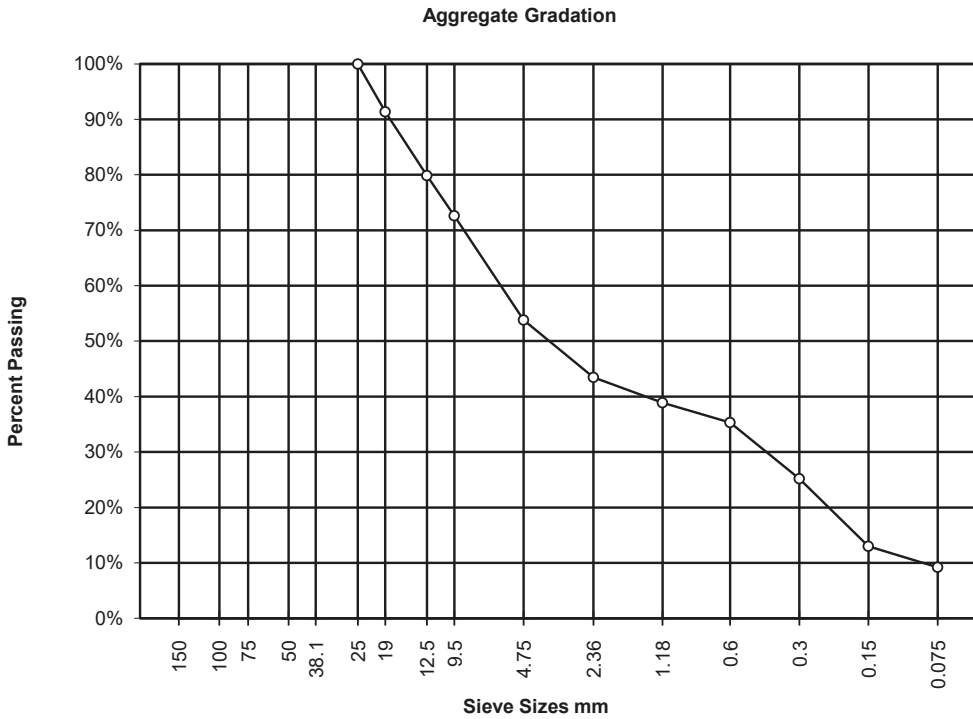
Classification Description: Poorly Graded Gravel with silt and sand

Aggregate Gradation		Specified Limits	
Sieve Sizes mm	Percent Passing	Minimum	Maximum
150			
100			
75			
50			
38.1			
25	100%		
19	91%		
12.5	80%		
9.5	73%		
4.75	54%		
2.36	43%		
1.18	39%		
0.6	35%		
0.3	25%		
0.15	13%		
0.075	9.2%

As Received Moisture Content = 3.3%

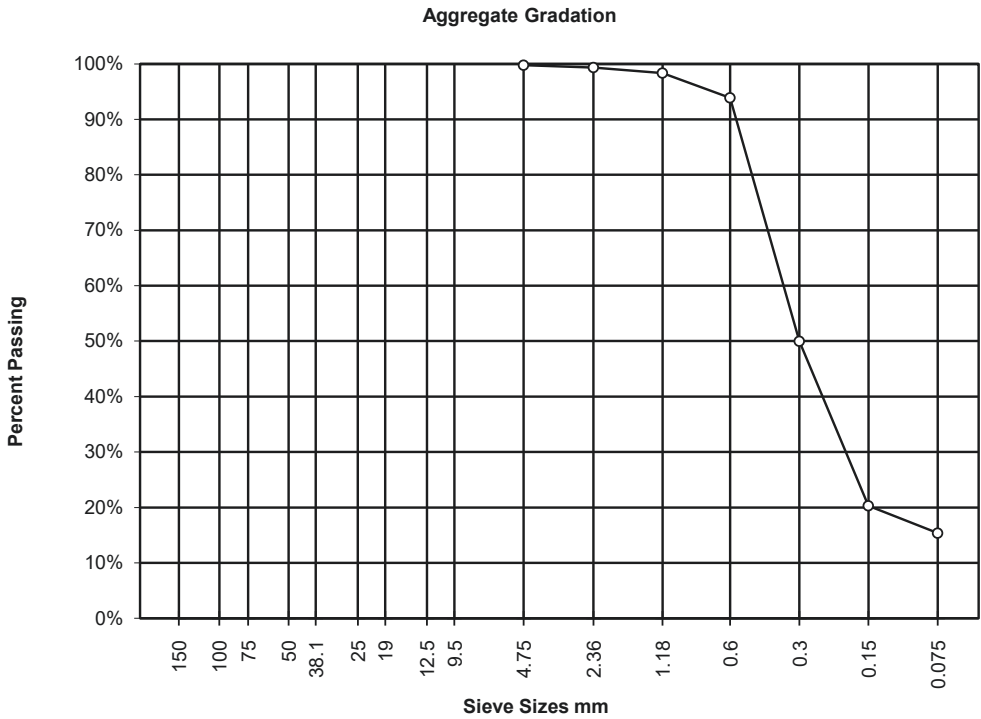
Classification Description: Silty Sand

Aggregate Gradation		Specified Limits	
Sieve Sizes mm	Percent Passing	Minimum	Maximum
150			
100			
75			
50			
38.1			
25			
19			
12.5			
9.5			
4.75	100%		
2.36	99%		
1.18	98%		
0.6	94%		
0.3	50%		
0.15	20%		
0.075	15%

As Received Moisture Content = 18.6%
