GEOTECHNICAL HAZARD ASSESSMENT

7099 Lantzville Road, 6852 Wiles Road
Lantzville, BC

File No.: E3761.03

Lewkowich Engineering Associates Ltd.

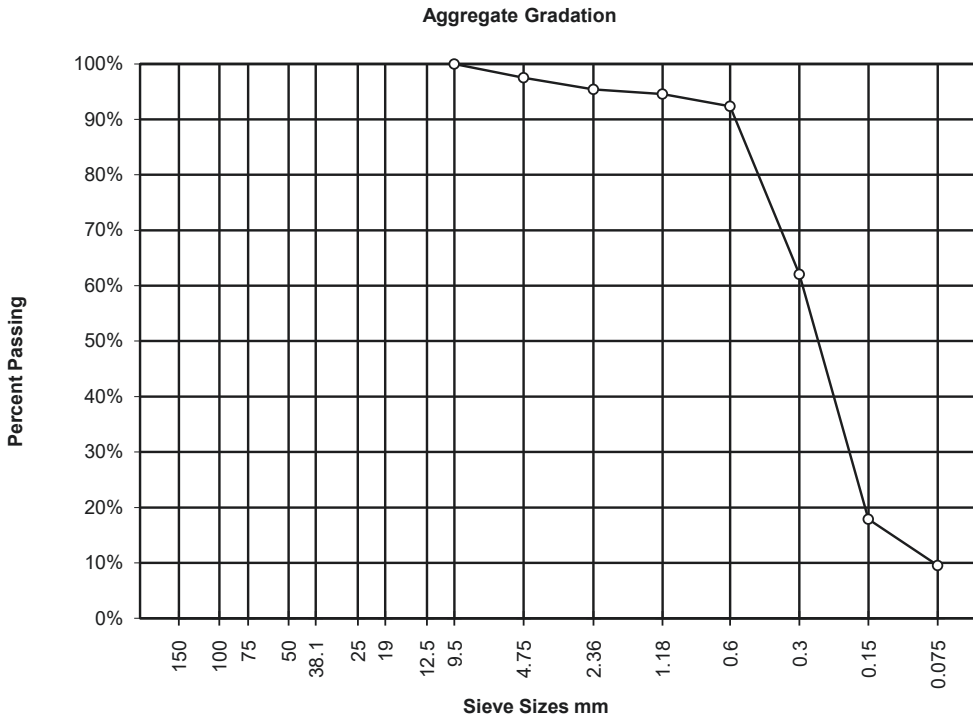
Classification Description: Poorly Graded Sand with silt

Aggregate Gradation		Specified Limits	
Sieve Sizes mm	Percent Passing	Minimum	Maximum
150			
100			
75			
50			
38.1			
25			
19			
12.5			
9.5	100%		
4.75	98%		
2.36	95%		
1.18	95%		
0.6	92%		
0.3	62%		
0.15	18%		
0.075	9.5%

As Received Moisture Content = 11.8%
