**SUBJECT: Community Use Building B – Facility Condition Assessment Report**

# FACILITY CONDITION ASSESSMENT

Facility Condition Assessment  
St. Philips Heritage Church  
7244 Lantzville Road, Lantzville, BC

**RE: Lantzville Heritage Church, 7244 Lantzville Road  
Structural Condition Report & Seismic Assessment**

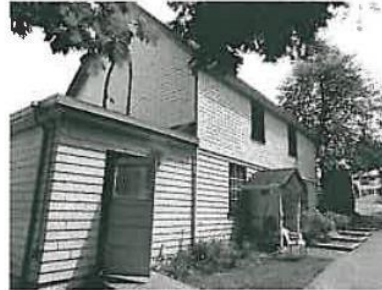
The building is thought to be about 90 years old. The building is on a sloping site with main entry at the upper level. The building has a footprint that is roughly 24' x 35', with a 10'x35' single storey addition at the back. The building is oriented with the long axis running north-south.

The building is a wood frame structure with concrete walls and foundations. The main building roof has a scissor construction with the roof pitch steeper than the ceiling joists. There is a center drop beam running along the east-west axis. The beams are 8x8 sawn timbers supported on 8x8 posts. The beam line is divided into three spans (12'-4", 12'-3", 9'-9" respectively starting at the east end). The west end span is offset about 24" to the north. Floor joists run from the exterior walls to the center beam. The floor joists are 2x8 @ 24".
